Archaeological monitoring report

**St. Catherine's Church
Rush Demesne
Kenure
County Dublin**

Community Monuments Fund 2022

Archaeological licence ref. 22E0482

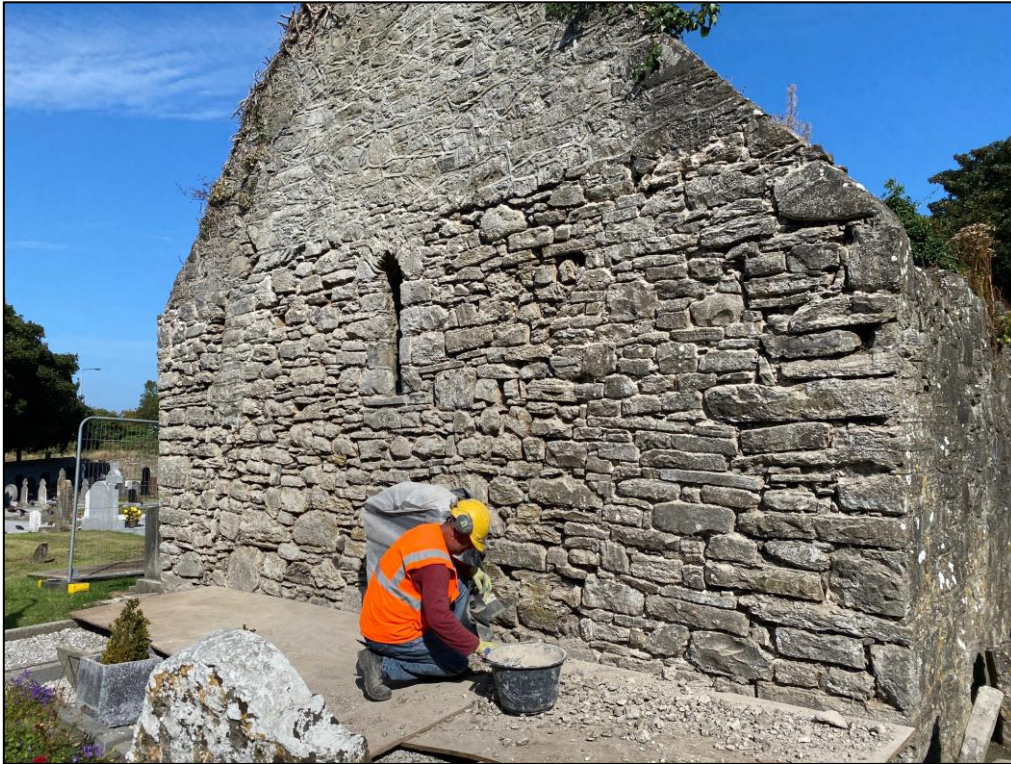
Plate 1 Removal of strap pointing exterior of western gable at ground level

- 4.2 Works on the monument commenced 26th August 2022 and this initially focussed on the removal of the strap pointing on the exterior and interior of the church's western gable using handheld tools in tandem with the removal of the vegetation from the interior of the church. The removal of the strap pointing of that gable, at ground level, progressed well (Plate 1) and subsequently the interior and exterior of both gables and the exterior north and south elevations were scaffolded to enable access at all heights of the structure to facilitate the works. At that point a sample panel of the proposed pointing was prepared for agreement, allowed to dry and subsequently approved. Scaffolding was erected with sufficient protection in place to respect the grave monuments internally and externally (Plate 2) to the church and particularly at the western gable. The remainder of the strap pointing of the western gable was then removed, as much as possible, but where it interacted with an area of intact rendering on the interior of the gable it remained untouched, in an effort to preserve some of what was possibly original rendering. An interesting recent element of the church's history was the signature of a 'T.O' Driscoll 1973' (Plate 18) which was visible on an upper elevation of the western gable, and it is possible that Mr. O'Driscoll might have been responsible for at least some of the unsympathetic strap pointing which was added to the church at that point in time.

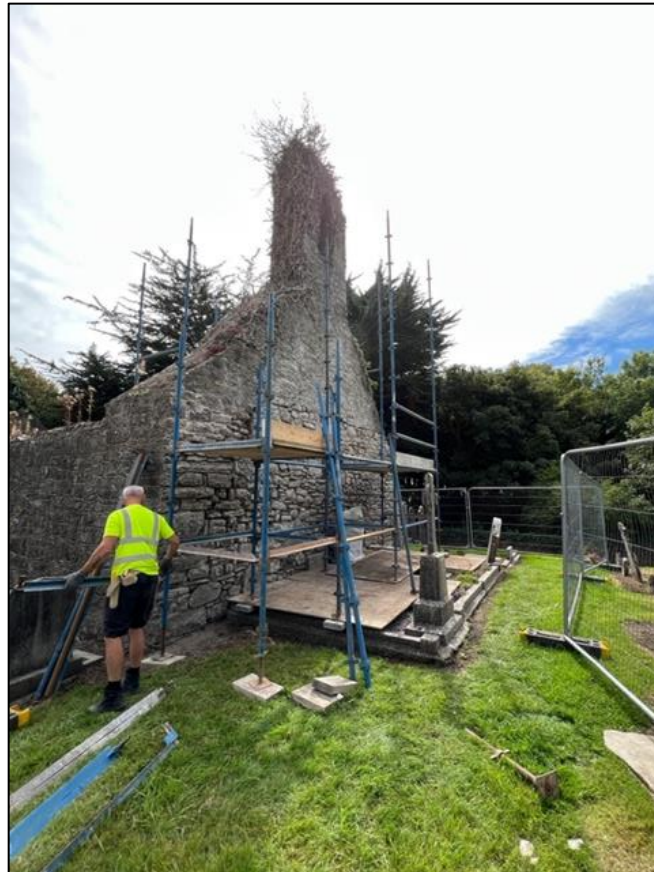
Plate 2 Scaffolding erection on western gable exterior, gravestone in bubble wrap

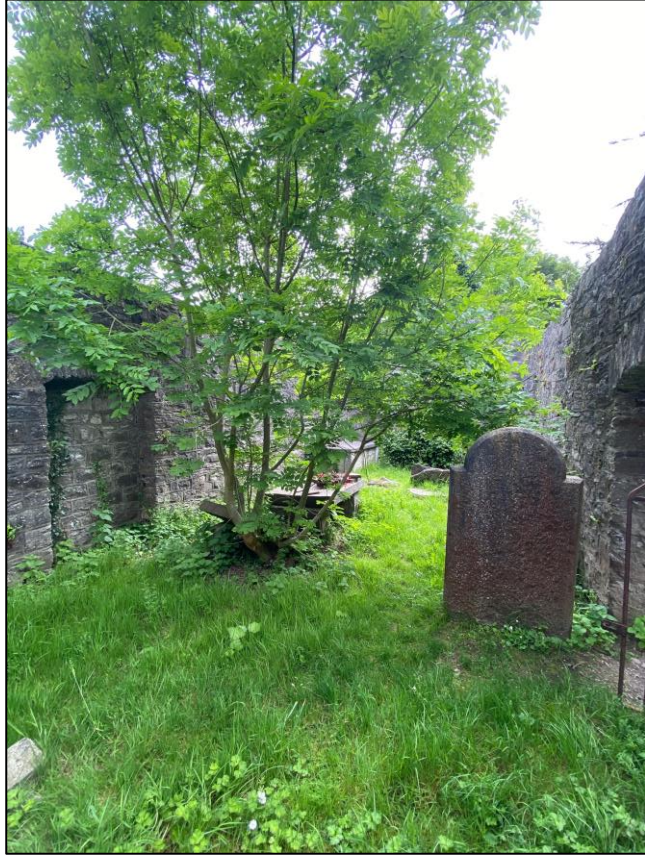
- 4.3 The growth of vegetation on the interior of the church (Plate 3) had served to damage the central table tomb and obscure many of the other internal monuments. The ash tree which had caused the former was cut down to stump level, with the stump drilled and treated to prevent regrowth. Additionally, the act of vegetation removal uncovered part of the northwestern pillar of that broken central table tomb, and this was matched to its *in situ* other half (Plate 4) and both pieces were cemented together with a chemical polymer. Once that polymer had cured the two halves of the damaged tombstone subsequently reset atop the pillars (Plate 5). The vegetation removal also revealed that the table tomb beneath the eastern gable had experienced a high degree of subsidence (Plate 6), which had caused the damage to the decorative surrounding wrought iron railings of the tomb, which originally had been slated for removal, restoration and resetting. As the subsidence issue only came to light during these works it had not been costed for as part of the CMF 2022 works, however Fingal County Council will be funding the resetting of the tomb themselves presently, separate to the successful completion of the CMF elements of this project detailed in this report.

Plate 3 Vegetation on interior of church, prior to-removal

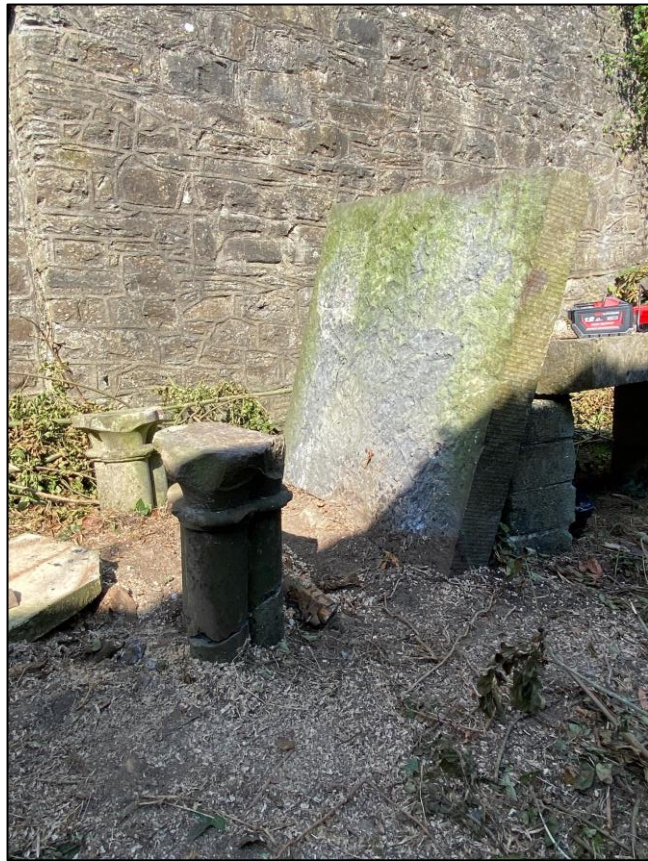
Plate 4 Northwestern column repair of table tomb interior of church

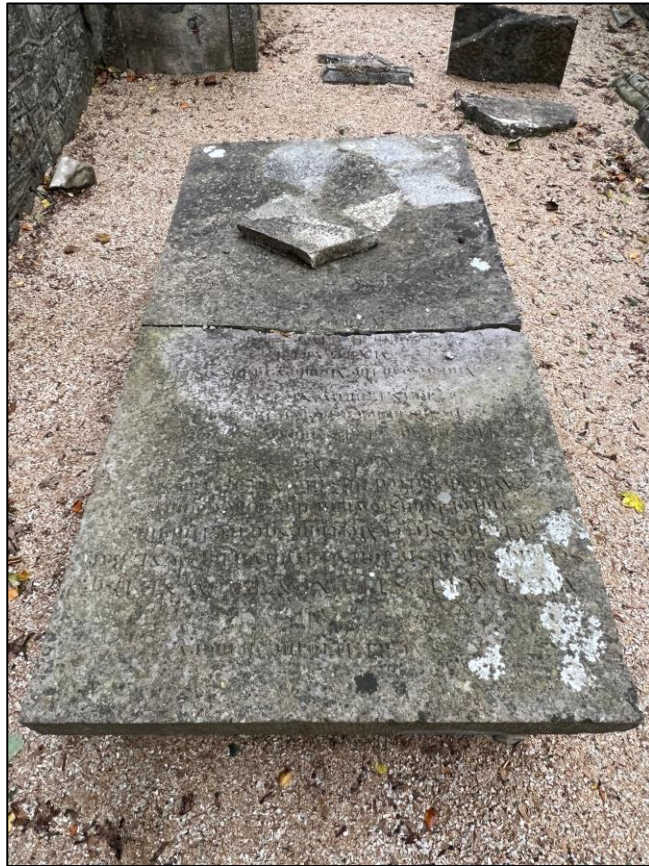
Plate 5 Reset pieces of central table tomb, facing east

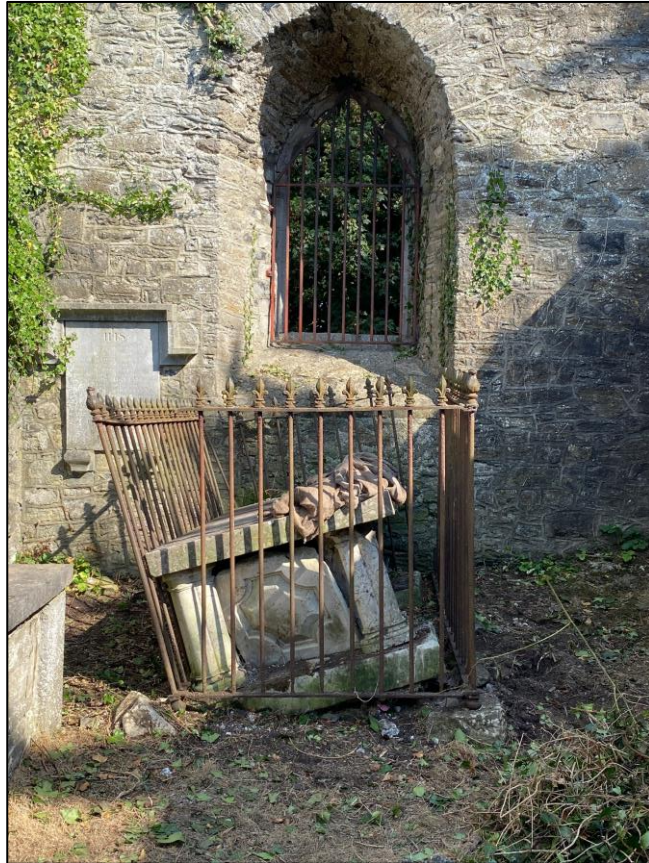
A wall plaque with a strong hood moulding was inserted after 1827 to the left of the altar, commemorating three eighteenth-century priests of the parish. A semi-collapsed table tomb, possibly that of Sir William Palmer (d. 1840) and surrounded by a similarly askew iron railing with finials is located just under the eastern window (Plate 6). Two further table tombs are present, one of which has been freshly repaired are present within the church, with the other which is intact and adjacent to the northern wall being the tomb of Baron Hamilton of Strabane. There are more modern headstones within the church, and only one the Mensa tomb fragments photographed by Healy (DU008-004003)(Plate 15) is still evident, adjacent to the southern wall (Plate 13). The Teeling headstone dating to 1743 is set into the ground against the southern wall.

Plate 6 Subsided table tomb interior to eastern gable of church

- Repair and reset the table tomb under the altar and re-position the restored railings surrounding it.
 - Laser scan the grave markers on the interior of the church, to create a permanent digital record.

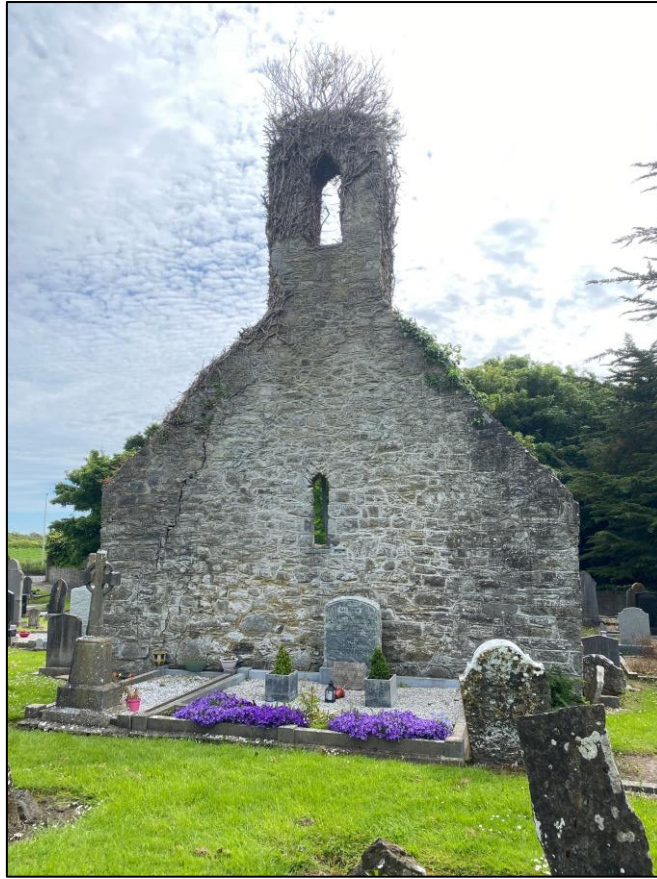
In a general sense the church would appear to be structurally sound; however, there was a significant crack evident on the western gable (Plate 7) with a smaller crack on the eastern gable (Plate 9). The removal of ivy growth on the elevations was previously attempted, exposing the relatively modern strap pointing which was evident throughout. The ivy was not however completely removed at the gables and prior to the works detailed in this report being carried out there appeared to be new growth on the eastern gable at the bellcote. The interior, accessible through a locked modern gate, had an uneven ground surface and there was vegetation obscuring some of the memorials within (Plate 3). One of the memorials within the church has its own discrete archaeological designation (DU008-004003), which comprised two fragments of a Mensa, or table tomb, dating to 1631, with one fragment bearing a crucifixion scene surrounded by an inscription contained within a border. This was not located during the measured survey and condition assessment previously conducted by ABH Ltd. (Myles 2020) and it likewise was not recorded on the Fingal Historic Graveyards survey in 2008. Both fragments were however photographed by Paddy Healy in 1984, but the 2022 CMF works revealed the upstanding fragment (Plate 11 & 12) to still be in place beside the 1743 headstone of Elizabeth Teeling, however of the crucifixion fragment there was no trace at time of writing.

Plate 7 Exterior of western gable, pre-repair with strap pointing

With the scaffolding in place, the treatment of all of the intramurally rooted vegetation was undertaken with herbicide and an examination of the substantial crack in the western gable revealed that it was not feasible to completely remove the ivy therein. As much of that root as possible was removed, with a small pipe left in order to periodically treat the remainder with herbicide. The ivy rooted into the eastern gable crack was treated in a similar fashion and following the vegetation removal and treatment, the resetting of the tops of the walls was undertaken and these were bedded and flanchied using a sympathetic lime-based mortar, to assist in water runoff. The same mortar was used following the removal of the strap pointing from the interior and exterior of the western gable to repoint those elevations, with a continuation of the repointing around the corners onto the initial 15cm of the northern and southern external elevations. The substantial crack in the western gable (Plate 7) and the lesser crack in the eastern gable (Plate 9) were repaired with steel stitch bars and repointed, to good effect in both cases, with the fresh mortar on both sides of the western gable completely masking the repair (Plate 8) and the only evidence of repair being the fresh mortar of present in the eastern gable (Plate 10).

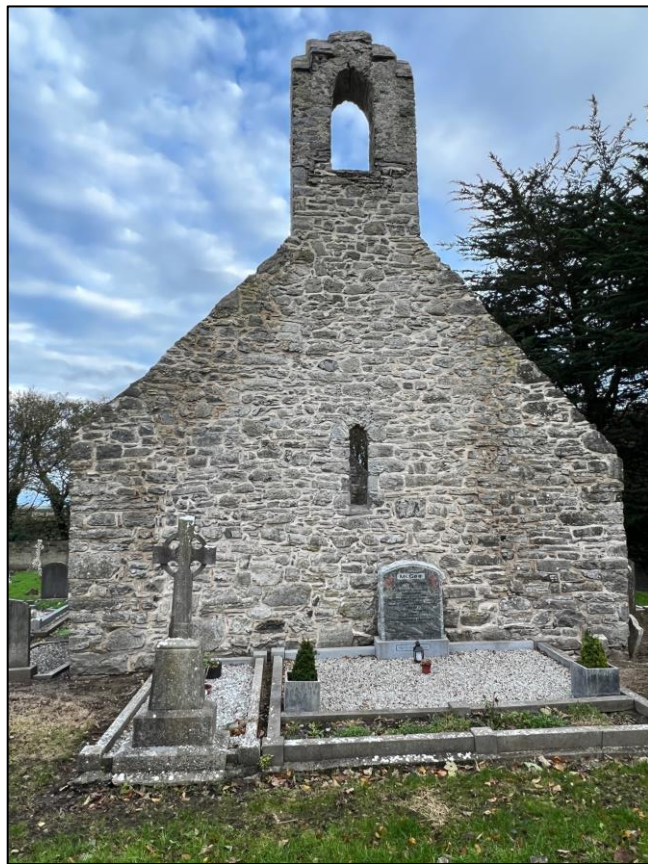
Plate 8 Exterior of western gable, post-repair and repointing

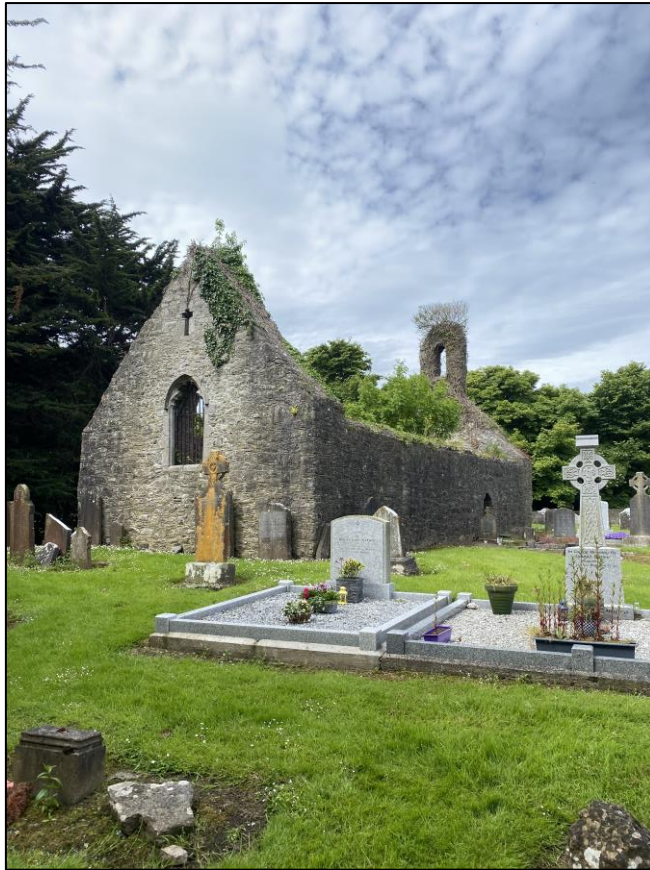
Plate 9 Exterior of eastern gable pre-commencement, with ivy in masonry crack, facing southwest

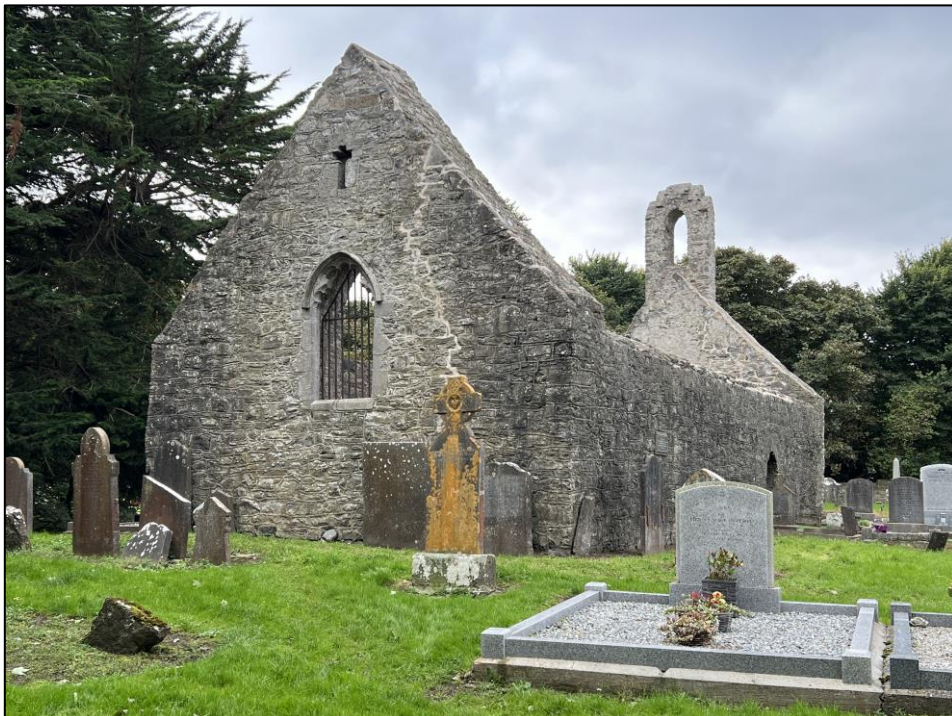
Plate 10 Exterior of eastern gable following repair, facing southwest

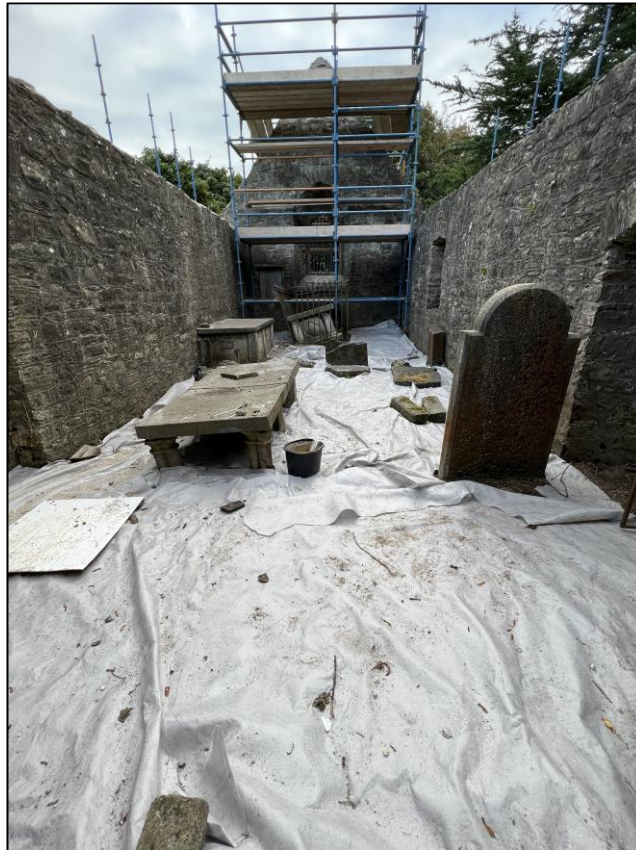
Plate11 Interior of church following geotextile imposition, facing east

- 4.4 Following the completion of the above works a layer of geotextile material (terram) was laid on the interior (Plate 11) to prevent vegetation regrowth and a particular type of gravel known as 'Ballylusk' was deposited in a 25mm layer to finish the interior of the church (Plate 12). At all times the on-site works were cognisant of the fact that despite the surrounding graveyard being of historical significance, it remains in use currently, with several modern gravestones and plots in close proximity to the works being protected and treated with the utmost respect and sensitivity at all times. No ground disturbance occurred during these works. During the above works the presence of two yellow sandstone rebates were noted, either side and internal to the arch of the church's belltower. The rebates (Plates 16 & 17) would have presumably held the bar which would have supported the church's bell and they were the only examples of this stone type used in the church.

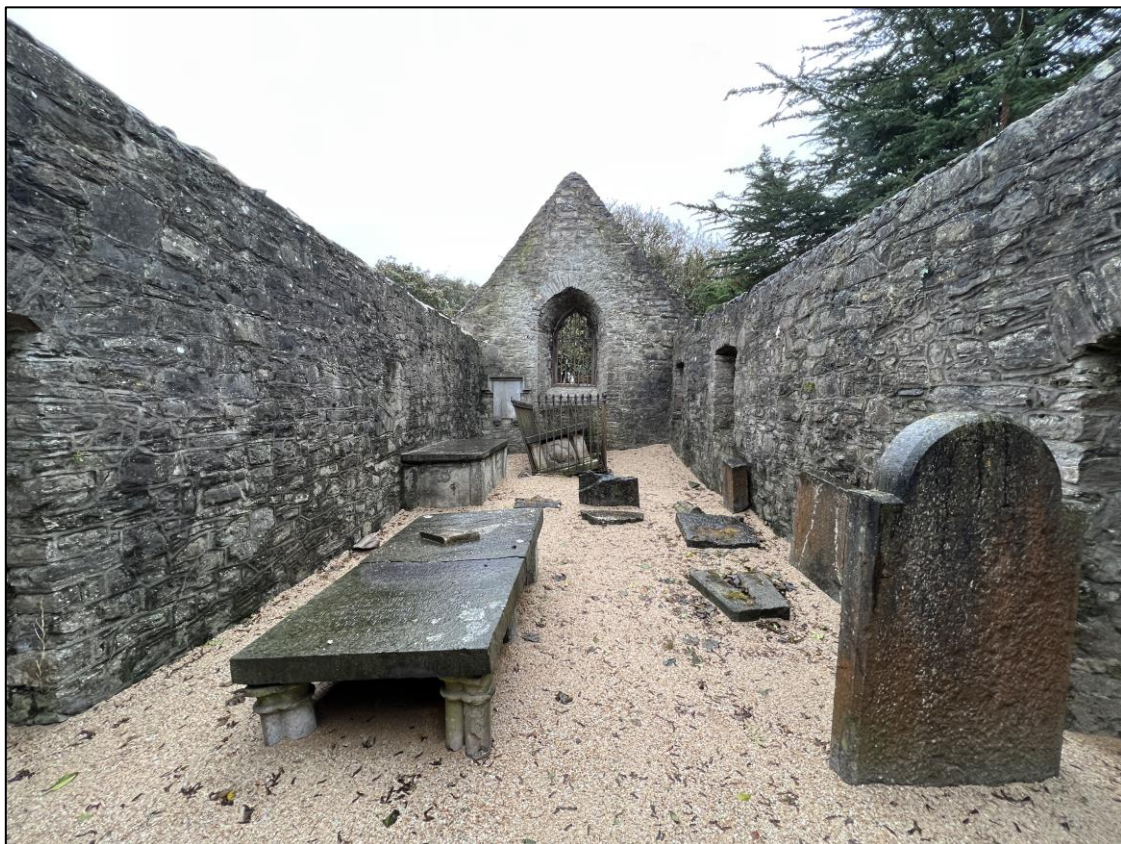
Plate 12 Interior of church after imposition of Ballylusk gravel surface, facing east

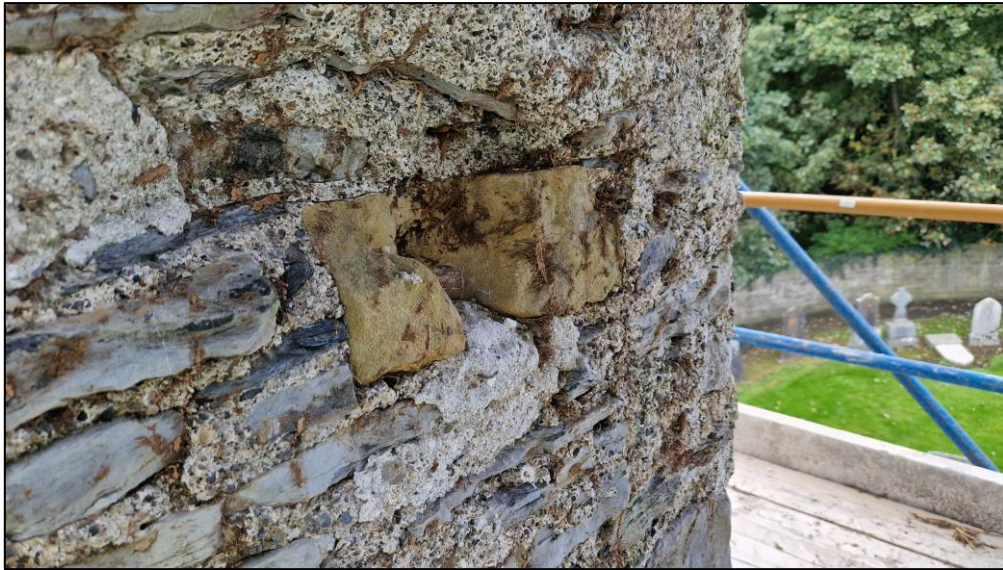
Plate 16 Yellow sandstone rebate in belltower arch, facing southwest

- Conduct non-invasive XRF (x-ray fluorescence spectroscopy) analysis in order to determine the chemical composition of the sandstone rebates (Plate 16 & 17) of the bell tower, which might allude to a provenance of those two stones.

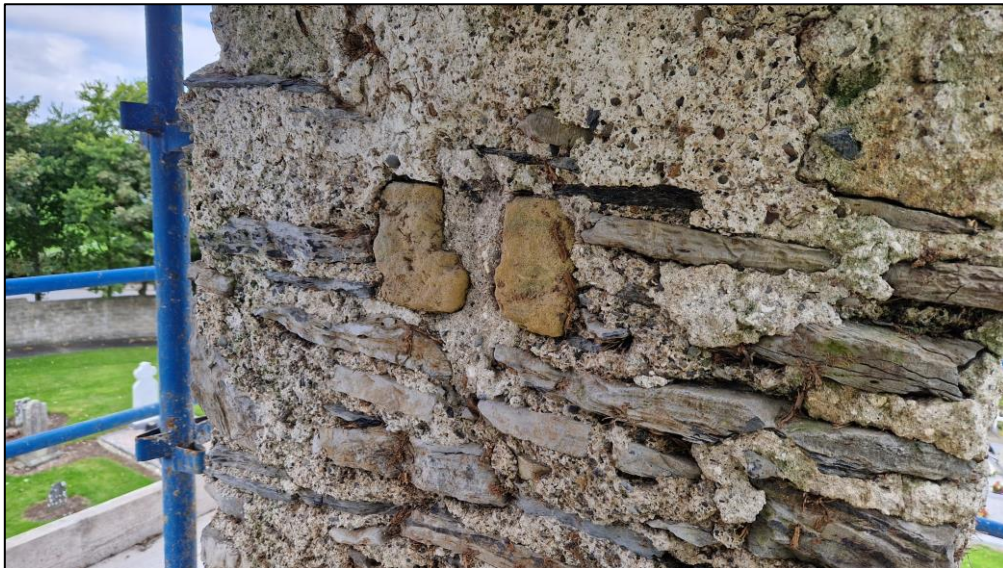
Plate 17 Yellow sandstone rebate in belltower arch, facing northeast

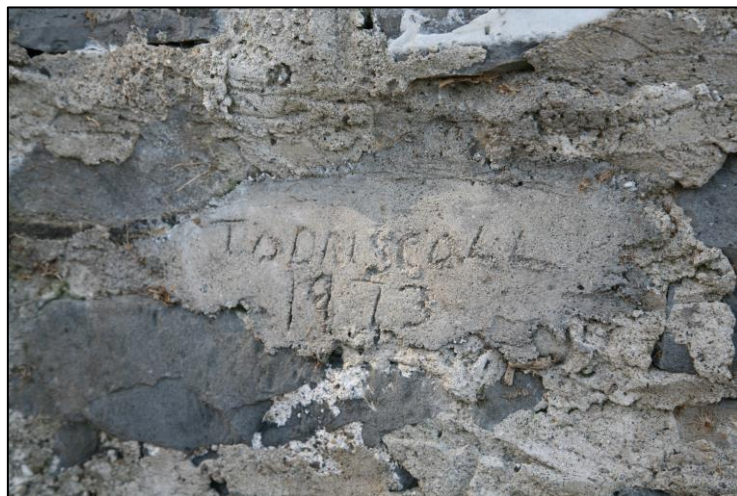
Plate 18 T.O' Driscoll 1973 signature on upper elevation of western gable
