Structural Assessment
Skerries Pier

Fingal County Council

16th November 2022

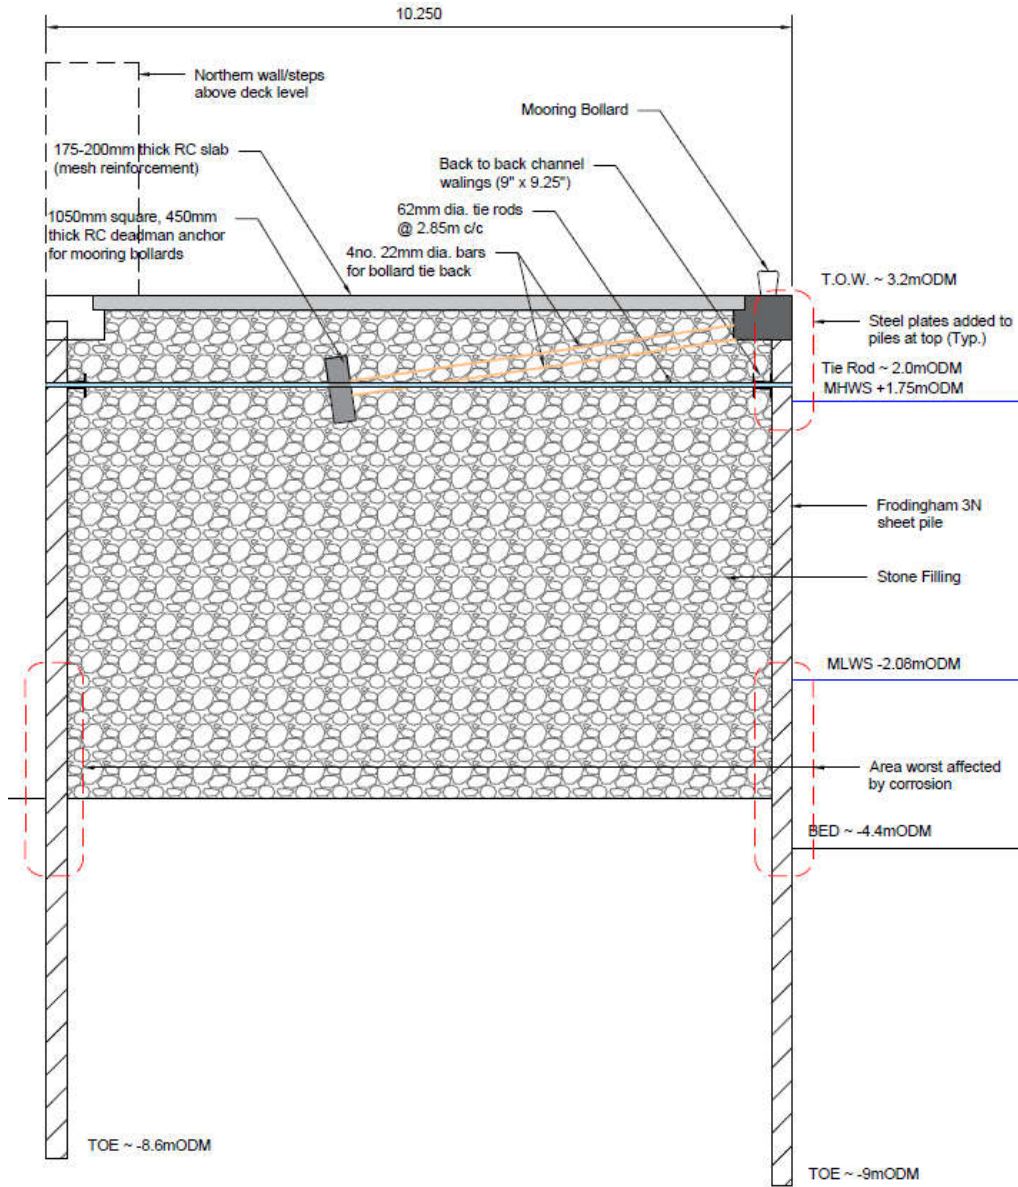
Figure 1 Typical Cross Section Through Existing Pier – Based on OPW Drawing

Based on the inspections carried out and the OPW drawings available, a typical cross section indicating the principal components of the structure is included on Figure 1 below. The key features are as summarised as follows.

The tie rods are located within the stone fill where IS EN 1993-5 indicates 1.2mm corrosion would occur around the perimeter of the bar in uncompacted fill. However, the stone fill at Skerries Pier is likely to be highly permeable with potential flow paths along the line of the tie rod. Therefore, it is considered that higher corrosion rates more akin to the splash zone could occur. On this basis the remaining tie rod diameter is expected to be approximately 55mm.

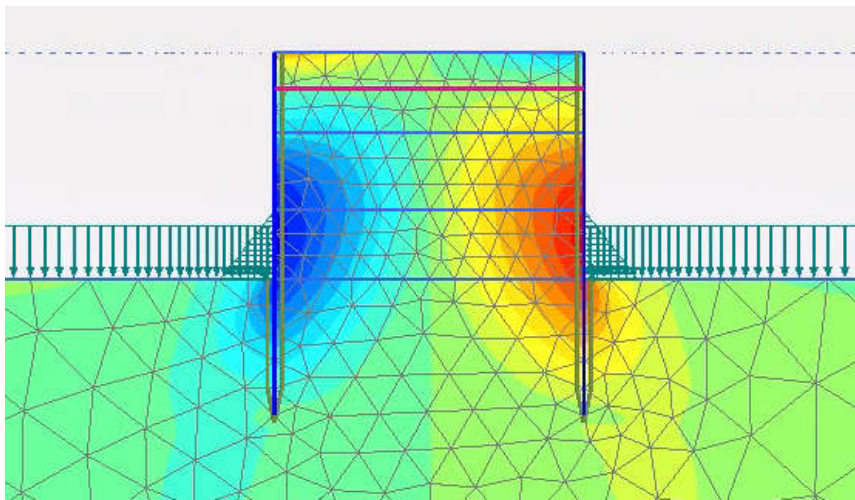
Figure 2 Plaxis 2D Plane Strain Model of Pier

A soil-structure interaction (SSI) analysis was carried out using a plane strain model in Plaxis 2D geotechnical modelling software. The arrangement of the model is indicated on Figure 2 below. The analysis considers earth and water pressure only, which are the predominant loads acting on the structure during calm conditions.

The analysis carried out indicates that the maximum stresses in the sheet pile wall, ignoring axial effects which are be relatively small, would be approximately 40% of the original uncorroded sheet pile yield stress. When the 50 year corrosion allowance suggested in IS EN 1993-5 is considered, the analysis indicates that the wall would be approaching its yield stress. The extensive voids in the outpan of the sheet piles near bed level would significantly reduce the capacity of the piling, and the analysis indicates that the piles would yield due to this loss of section.

The analysis indicates that the tie rods would be working well below yield stress, even considering normal corrosion rates over 50 years. Therefore, it is expected that a failure of the structure would be due to yielding and rotation of the sheet piles at some point above bed level, most likely near MLWS. It is anticipated that there is a degree of redundancy in the structure and some bending moments can be re-distributed away from severely corroded zones to other less corroded areas before a collapse would occur. As such a structure approaches failure, additional deformation, settlement, tilting and distress would usually be apparent. Although the sheet pile corrosion near bed level would cause the piles to be stressed beyond their yield stress, there does not currently appear to be any significant signs of distress which may otherwise suggest the structure is approaching collapse.
