Underwater Survey Report Steel Sheet Pile Survey Skerries Pier

Project Title:	Steel Sheet Pile Survey
Location:	Skerries Pier
Document No:	21-018/UI01

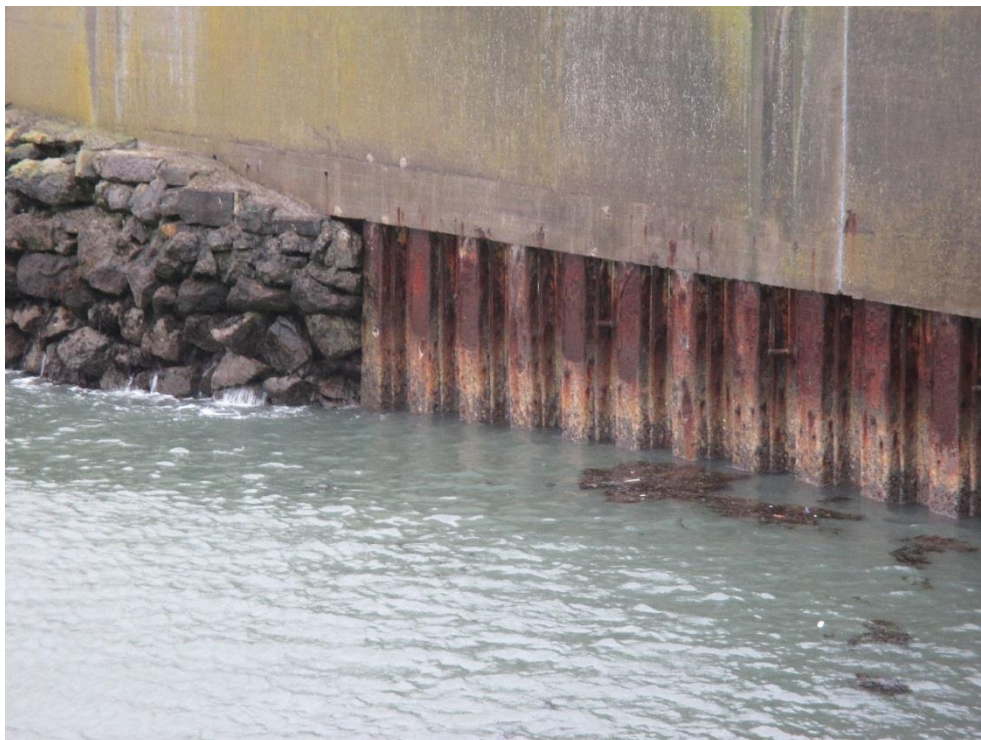
Fig B4 – Northeast Wing at Outpan No.1 – Typical Condition

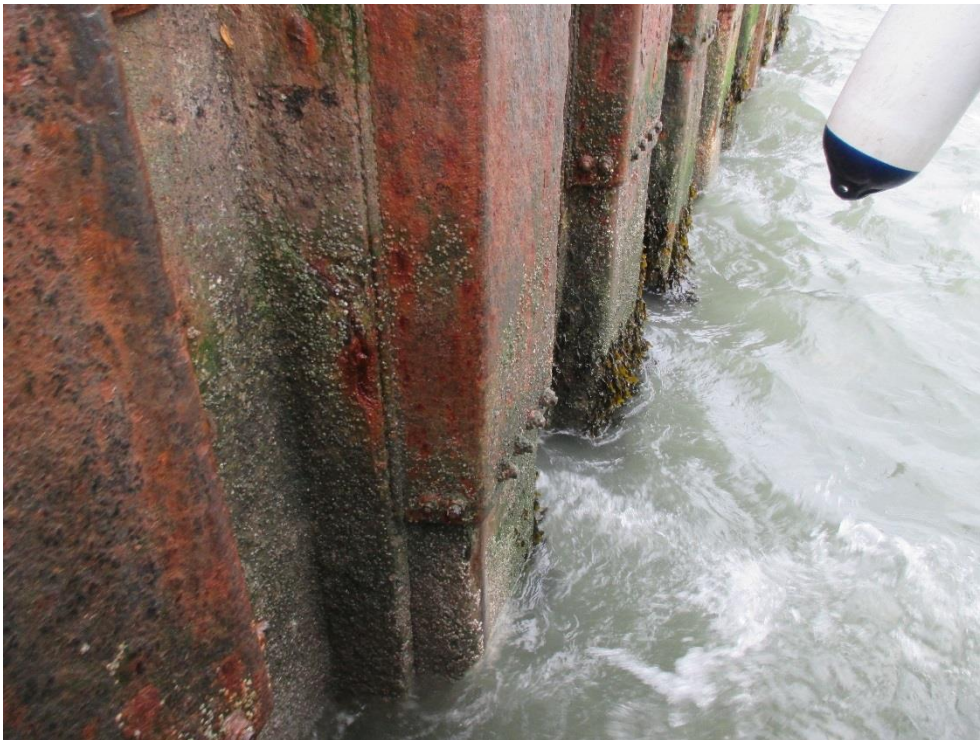
The majority of the Outpan piles on the West (End) face and the South Face of the pier have been repaired in the past with a section of pile fitted over the original pile and bolted to the steel below and the face of the concrete capping beam above. Through historical photographs found online it is evident that there was advanced corrosion within the Splash zone in these locations with extensive holes throughout. The cover sections transfer load from the tidal zone of the pile to the pile cap, but the connection detail is not fully known. (Pics B8 & B9)

Fig B8 - Existing Repair at top of piles – Typical West and South Faces

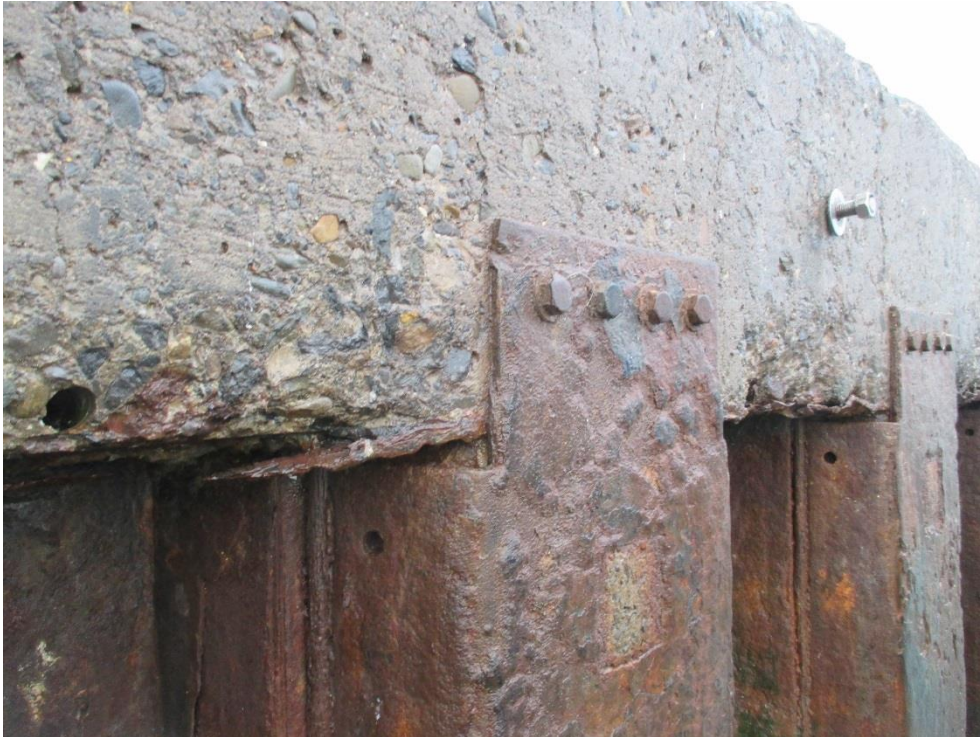
Fig B9 - Existing Repair – Top Connection detail with Capping

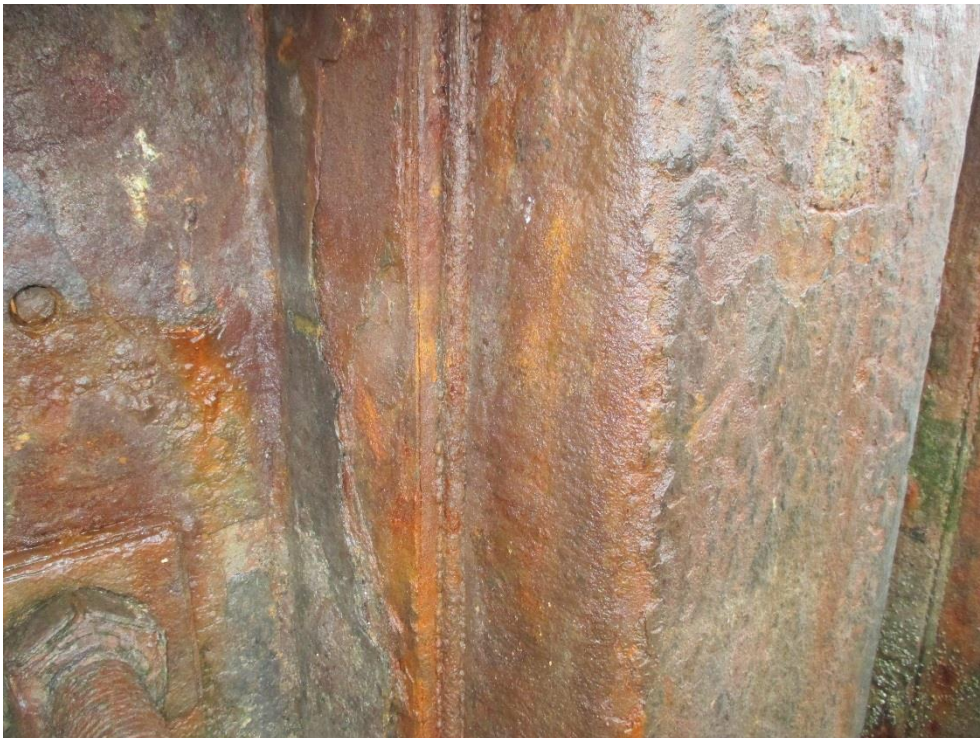
There is moderate corrosion delamination in all locations within the splash zone, with moderate corrosion pitting evident on the steel surface. (Pics B10 to B12)

Fig B10 - Typical Steel Condition at Top of Tidal – Splash Zone

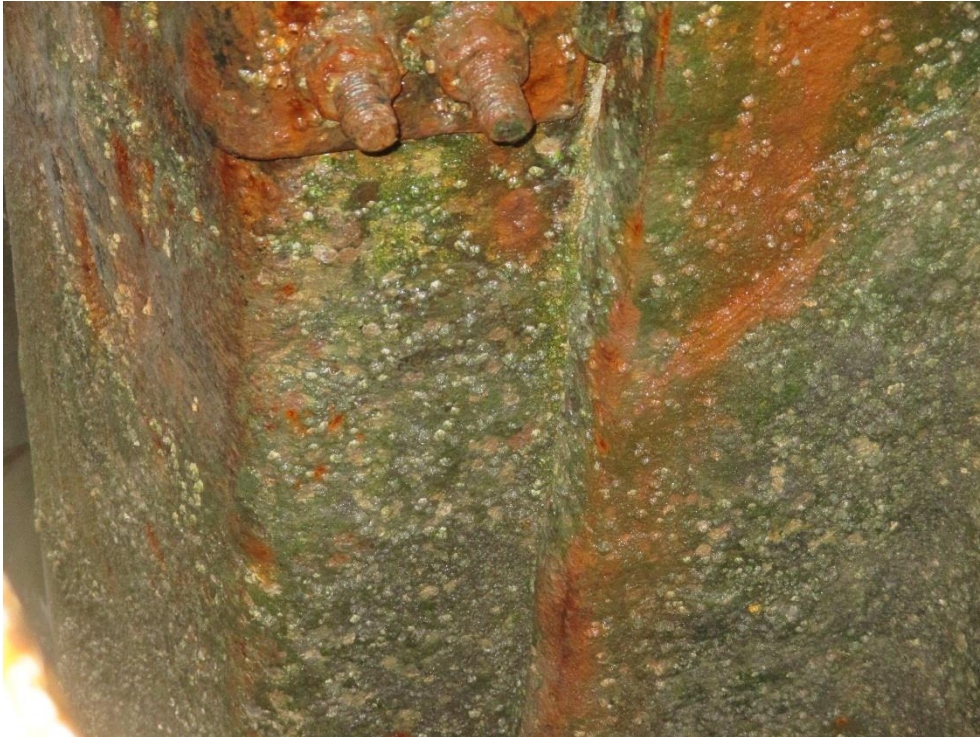
Fig B11 - Typical Condition within Intertidal Zone, beneath repair plates.

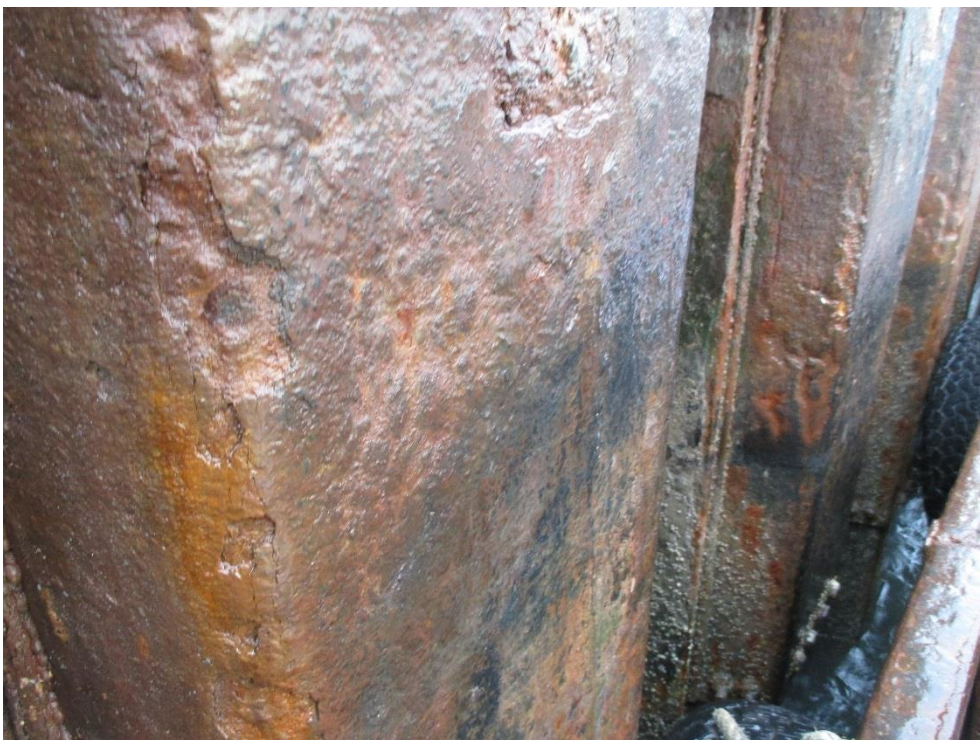
Fig B12 - Typical corrosion delamination and pitting

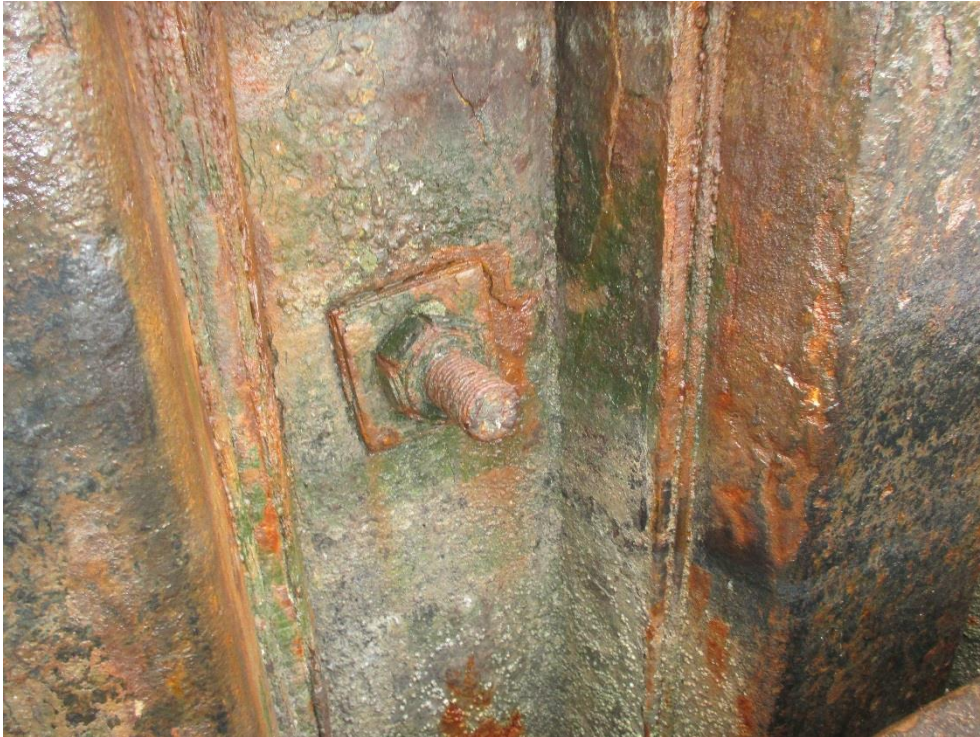
Fig B13 - Typical Condition at tie bar level at top of tidal zone

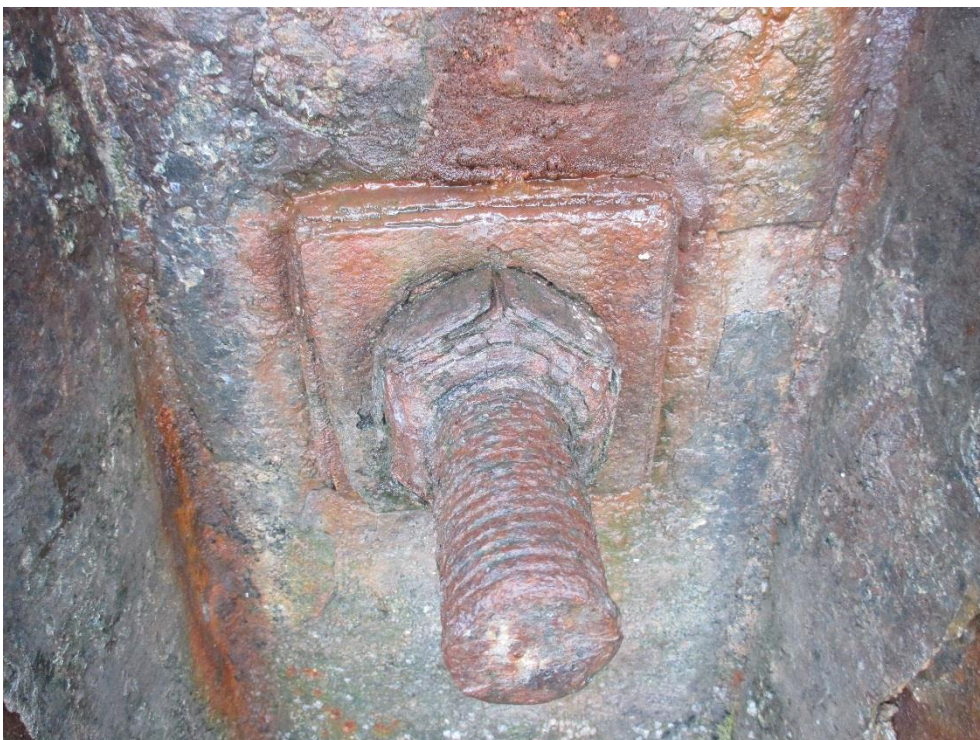
Fig B14 - Typical Tie Bar and surrounding steel condition

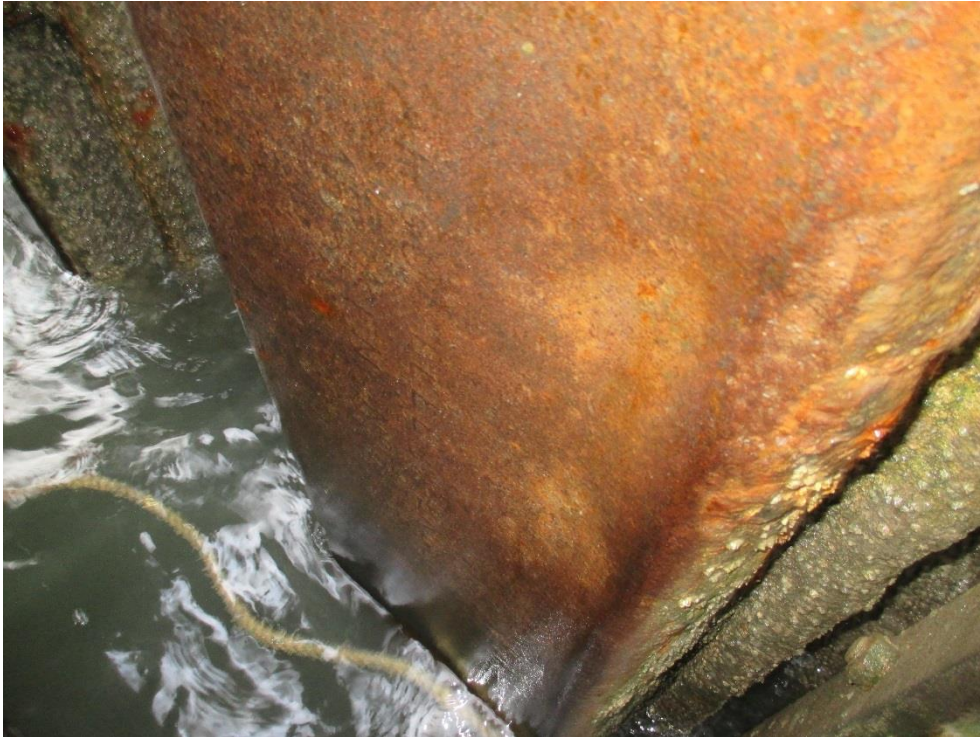
Where more significant loss of thickness or hole defects have occurred, these have developed from more advanced corrosion below extending up into the intertidal zone. (Pics B15 to B17)

Fig B15 - Typical Steel Surface condition within intertidal zone along South Berth face

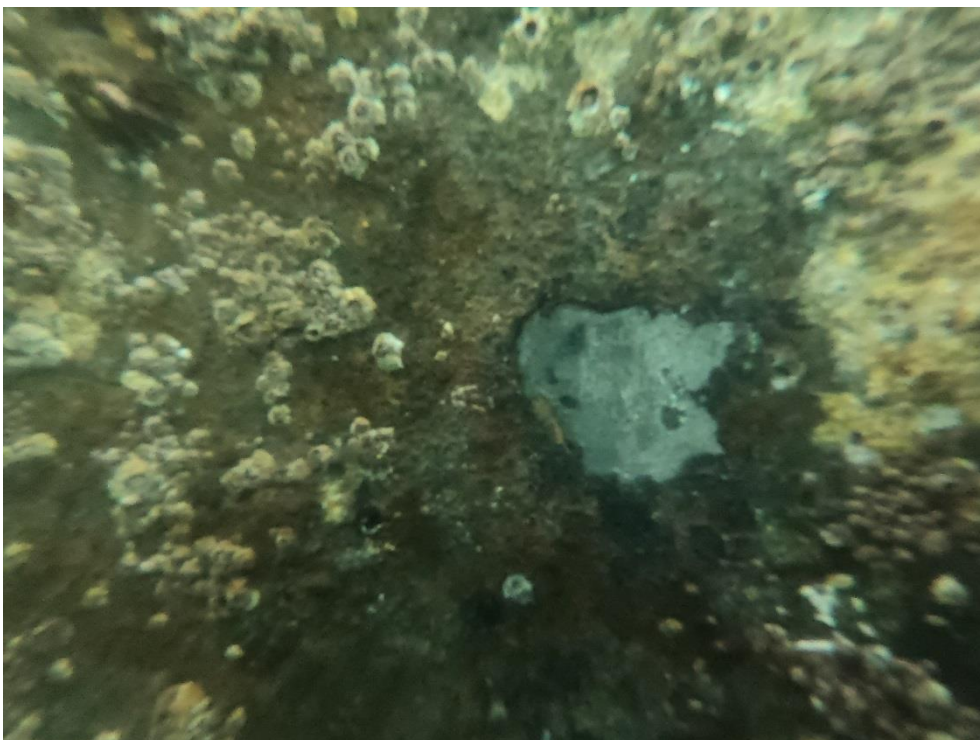
Fig B16 - Typical Steel Surface condition at lower Intertidal Zone
(Corrosion removed for UT measurement)

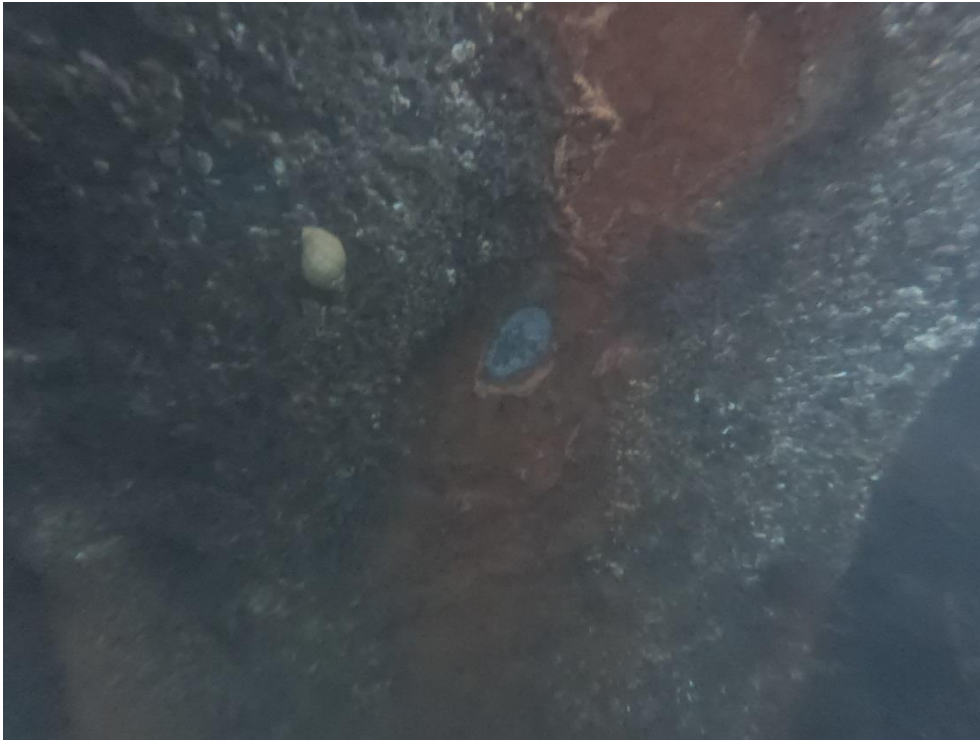
Fig B17 - Measurement location at lower intertidal zone (North Face)

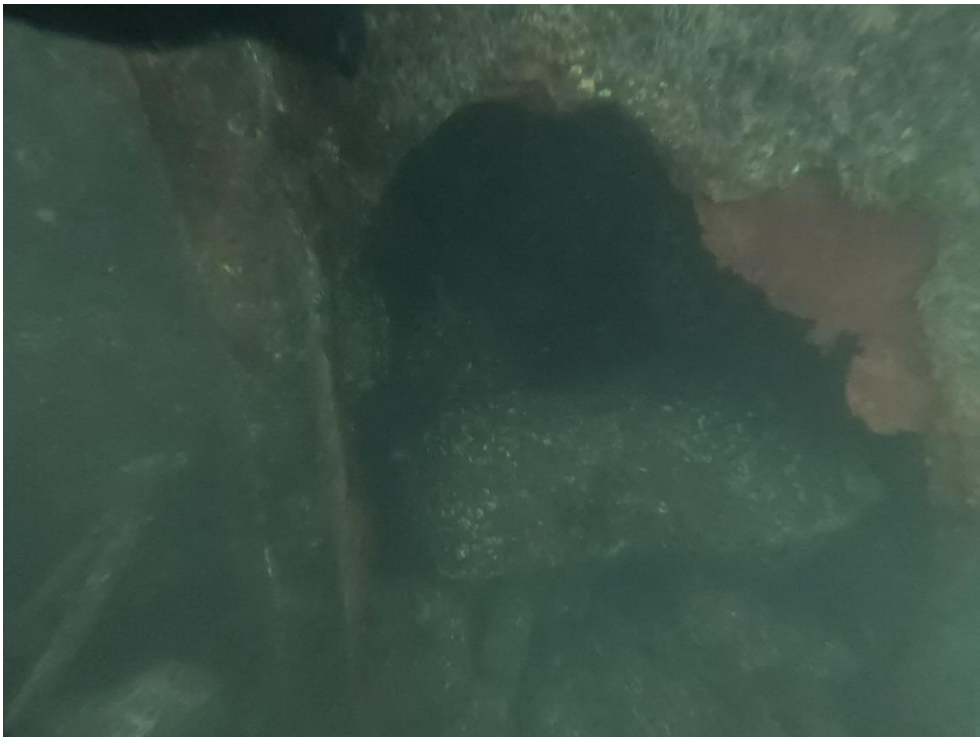
The Northeast wing and North face do not have as significant material thickness loss as found elsewhere. The seabed covers some of the MLWS level offering protection in part. There are 3 piles with holes in the Northeast Wing and 4 piles along the North Face.

Fig B18 - Hole at bottom of Pile above MLWS – Outpan No. 13, Northeast Wing

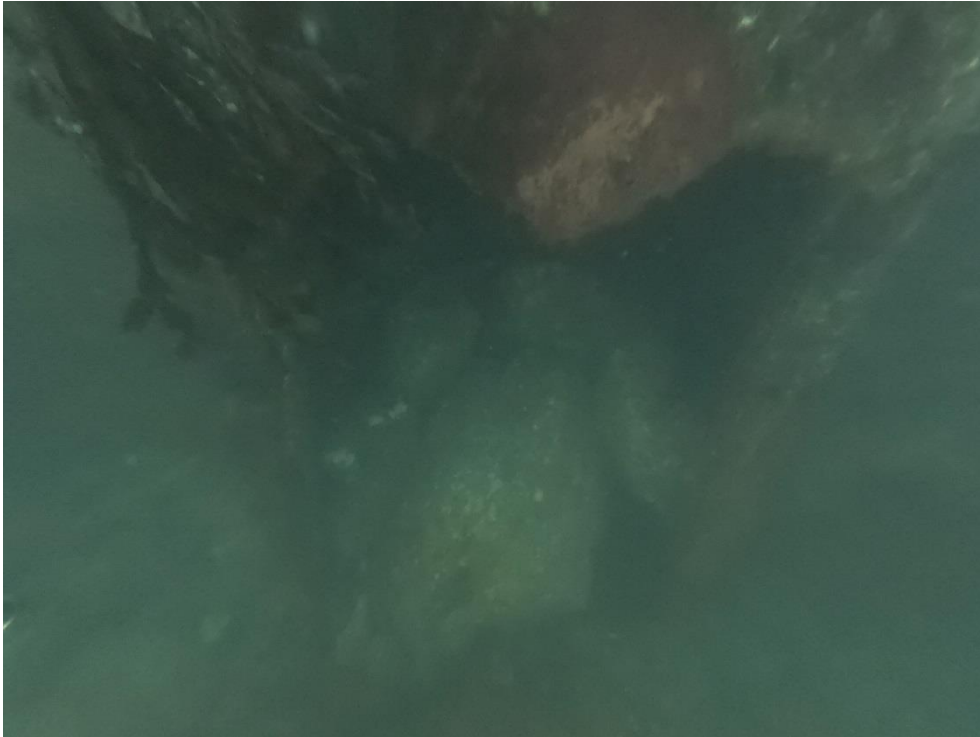
Fig B19 - Hole at bottom of Outpan No. 15 – Northeast Wing

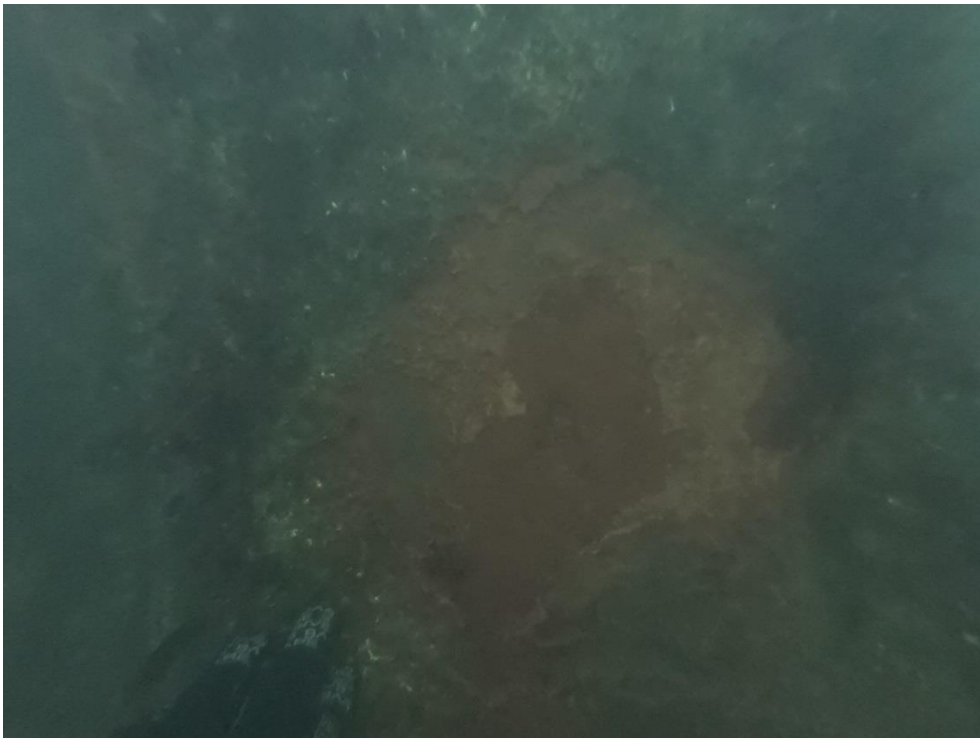
There is active corrosion blooming around the MLWS level that is typical of Accelerated Low Water Corrosion (ALWC) along all faces of the pier.

Fig B20 - Typical Active Corrosion at MLWS

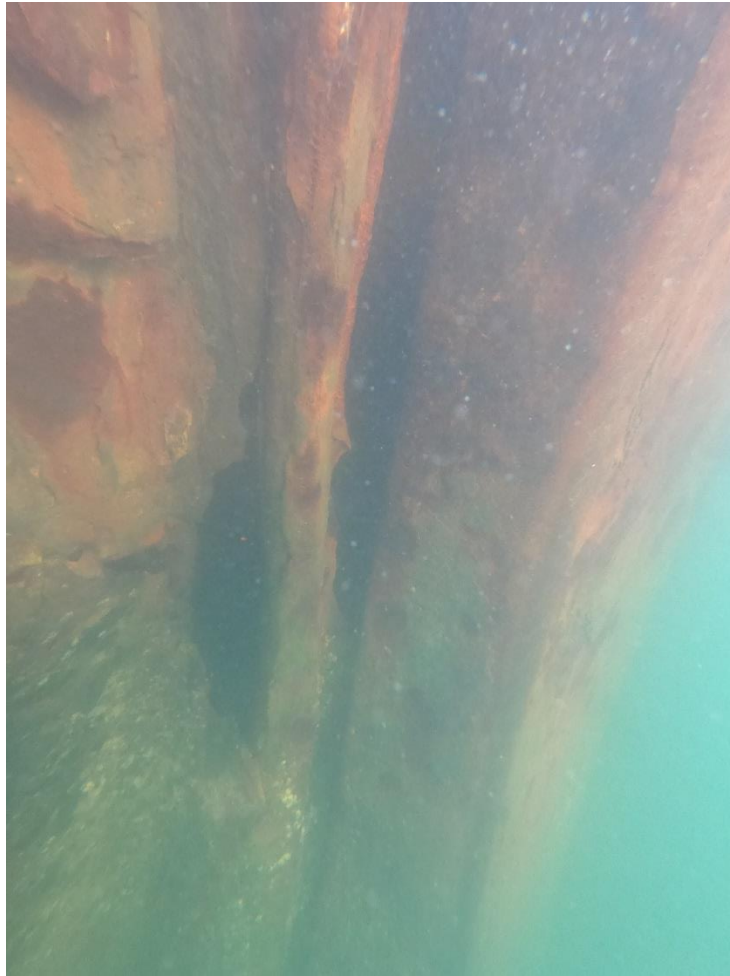
Fig B21 - Hole at MHWS level at corner with North – West Face. Outpan No. 111

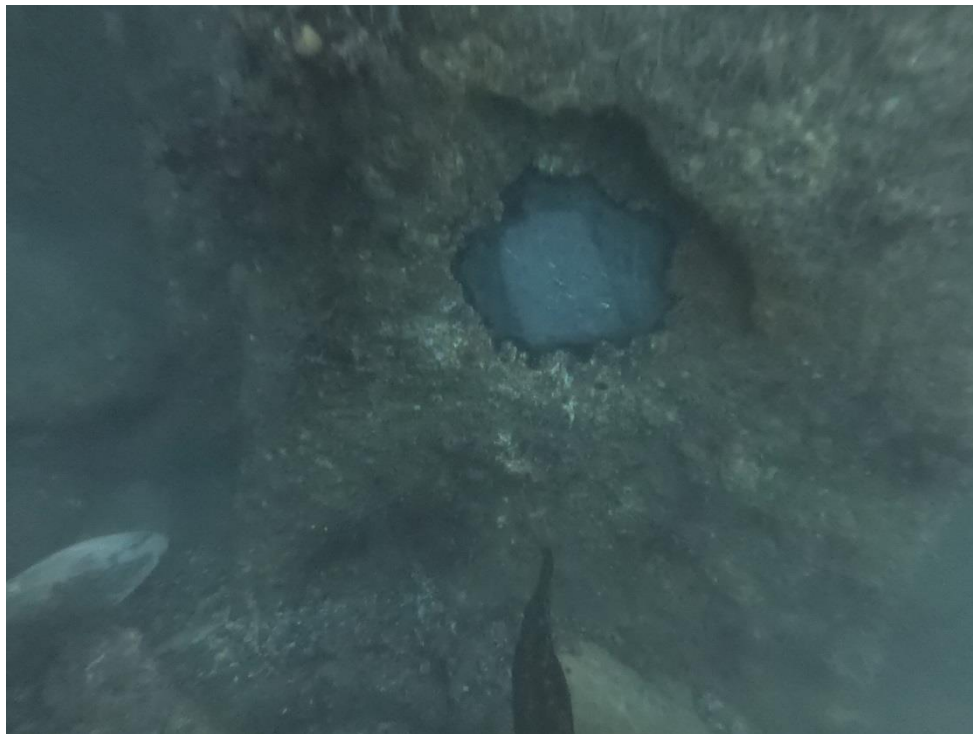
Fig B22 - Thickness Measurement location. Note clean steel beneath (MLWS)

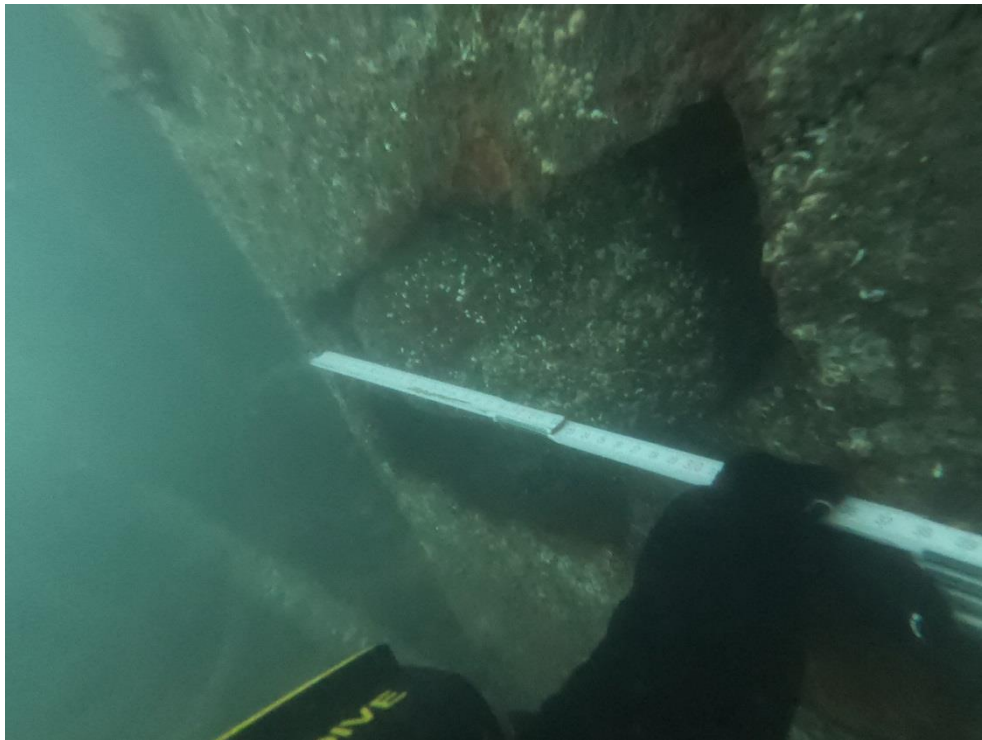
Where holes were found in the steel piles, large stone fill material was evident within the pier structure. The stone is a rounded boulder stone up to approximately 500mm in size. There was localised voiding within some of the holes where the fill material has escaped to the surrounding seabed.

Fig B23 - Hole at Outpan No. 95 – Note Large fill stone within

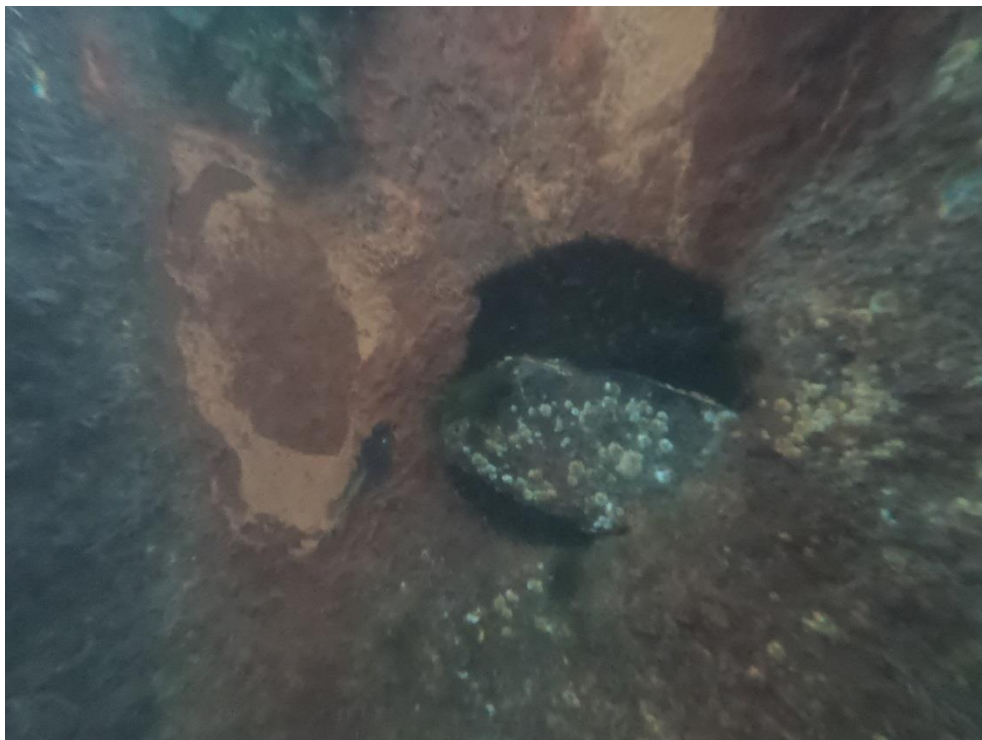
The holes have developed through ALWC with the low water zone. ALWC was clearly visible during the survey along the entire pier length, and it would be reasonable to assume that further holes would continue to develop in short time.

Fig B24 - Hole at MLWS, Outpan No. 119 – ALWC evident at same level.

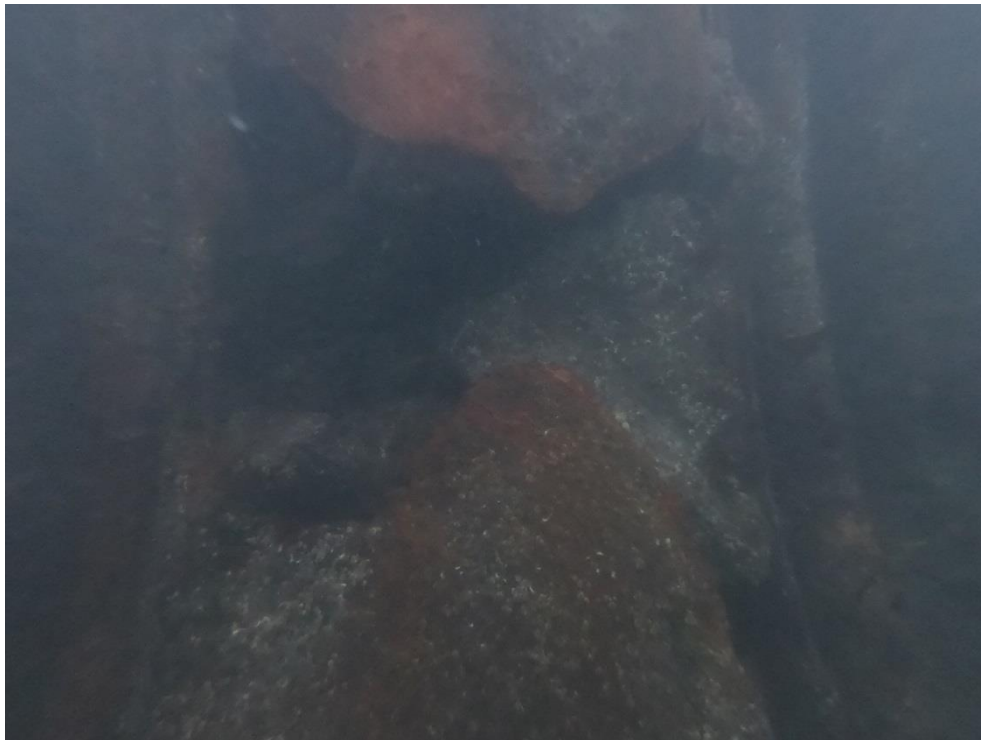
Fig B25 - Hole at MLWS, Outpan No. 117 – Typical at same level

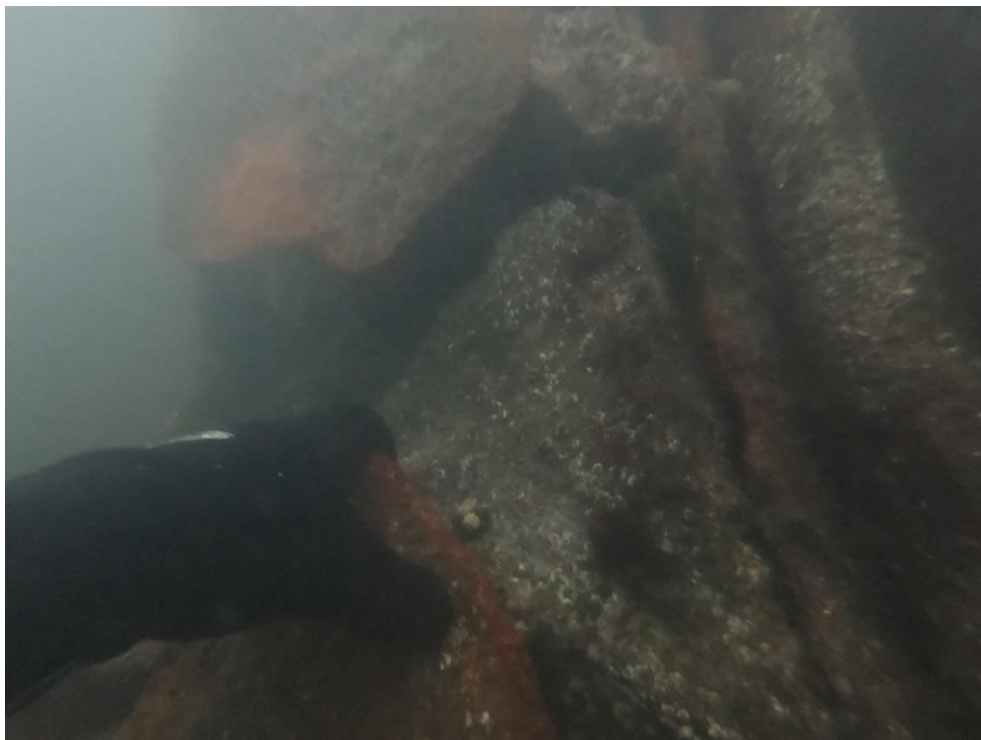
Fig B26 - Thin remaining steel / Loose fill stone within – Typical detail

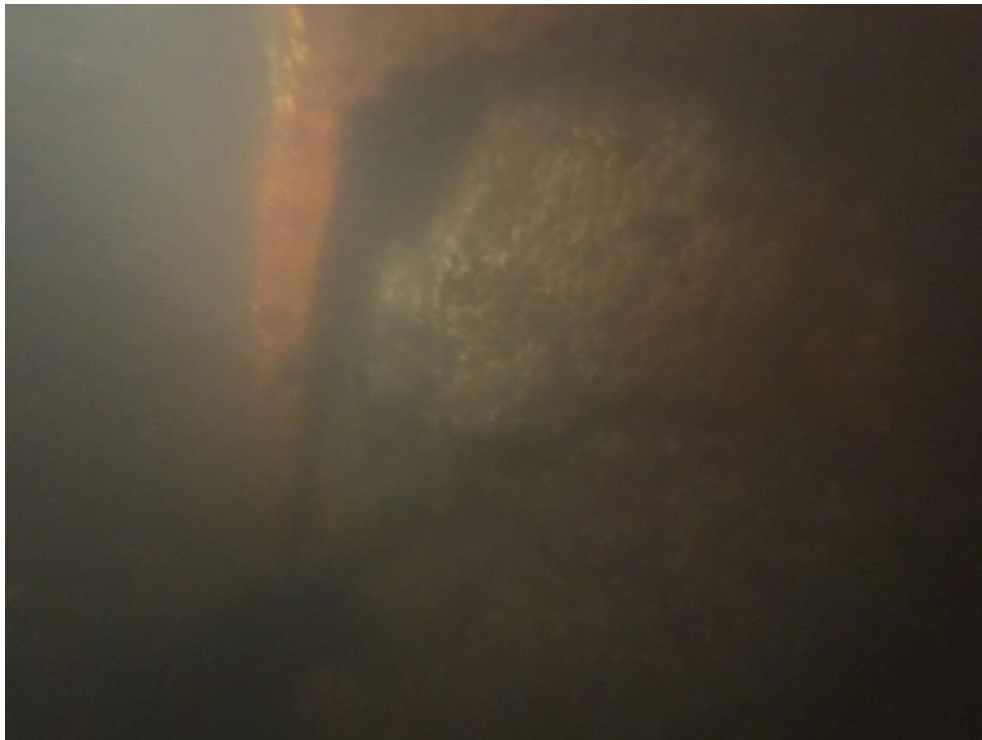
The hole defects and advanced corrosion at MLWS level along the West (End) Face and South Face are assessed as critical with load bearing capacity significantly affected.

Fig B28 - Hole at MLWS, Outpan No. 149 – Full loss of pan face –
Typical detail along South face

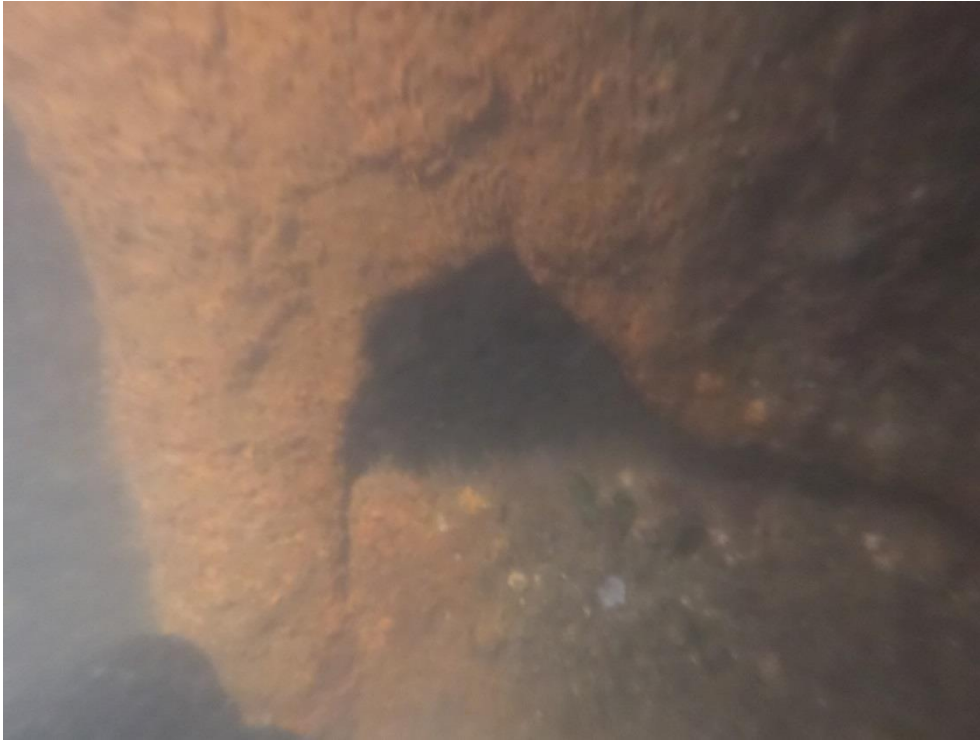
Fig B29 - Typical Hole in Pile at MLWS along South Face -

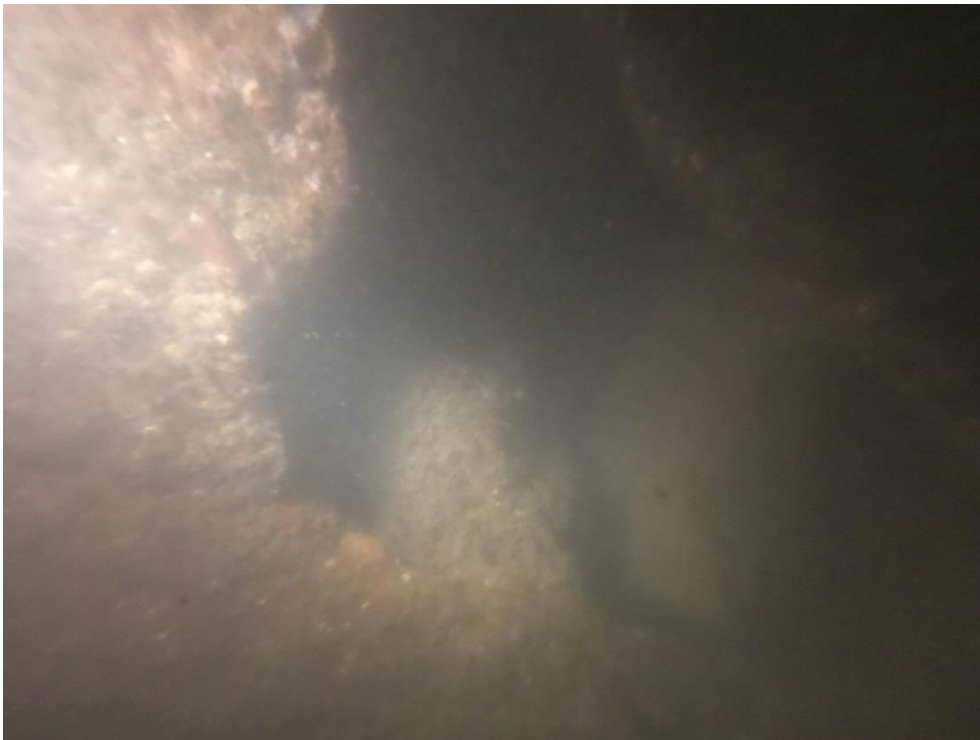
Fig B30 - Hole at Bed level – Outpan N0. 217 – Note Void behind

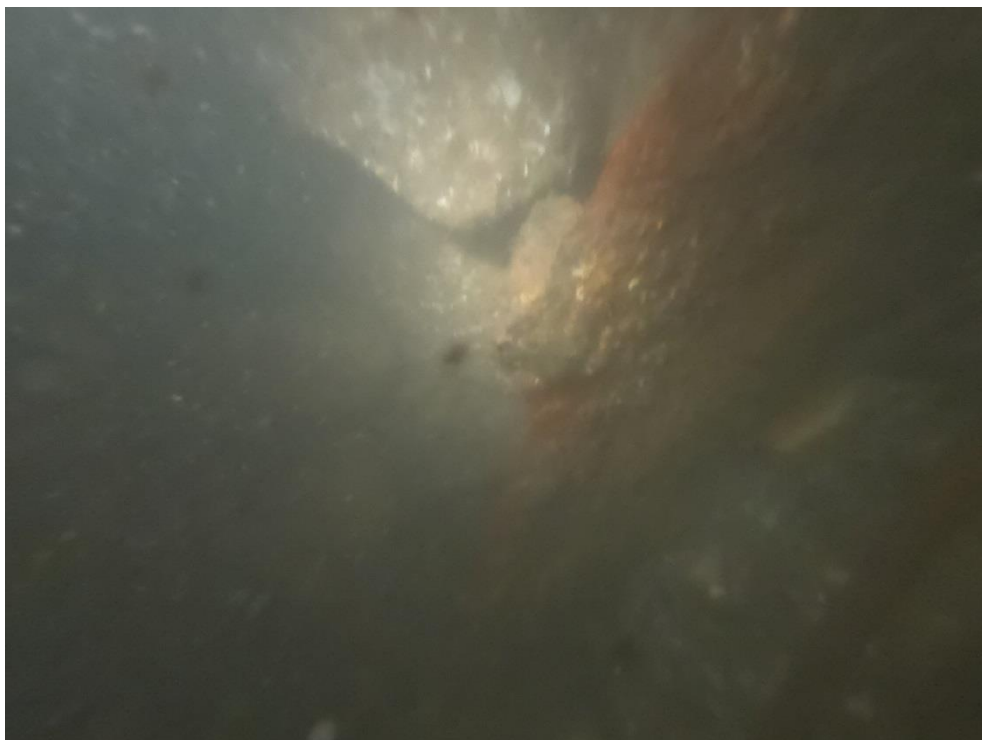
Most of the piles along the West and South faces have holes within the low water zone. Some of the holes extend up to 3m up the piles, with loose, sharp flaps of steel remaining at the bottom.

Fig B32 - Loose flap of Steel following loss of pan face – Typical

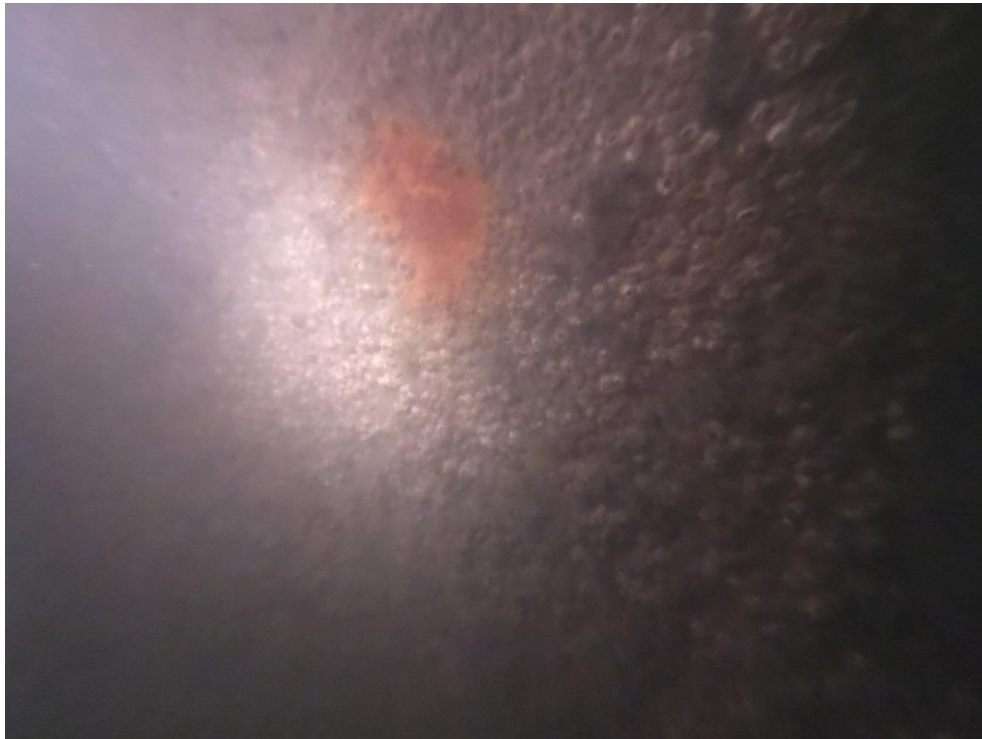
Fig B33 - Typical Isolated Corrosion Spot

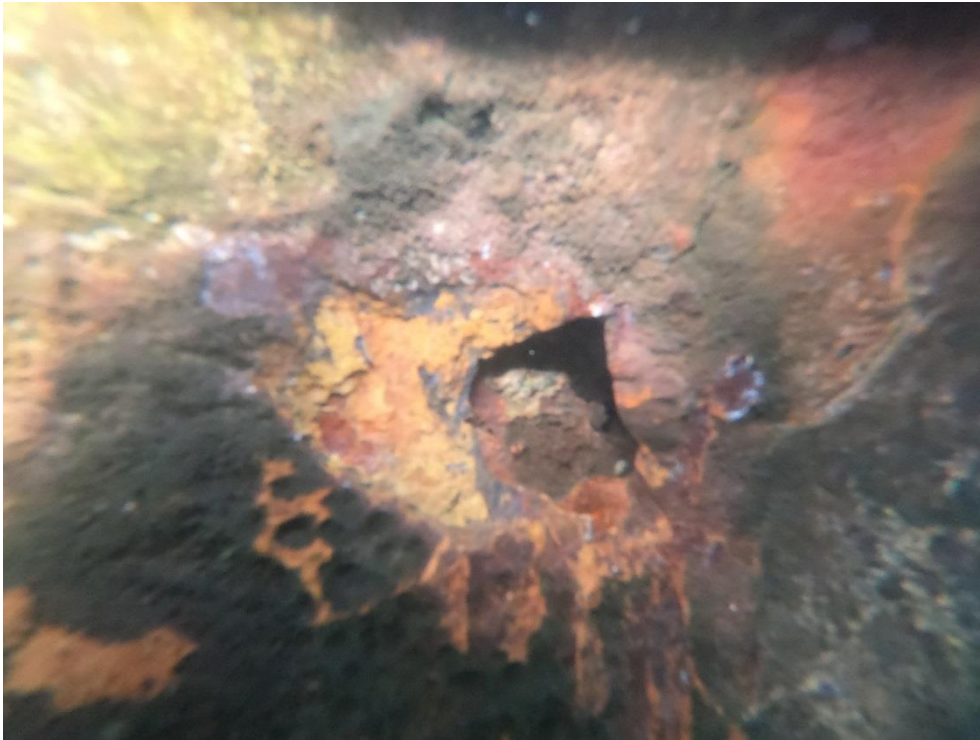
Fig B35 - Hole beneath Repair Plate at top of Outpan No. 173 – Very thin material surrounding repair
