Archaeological monitoring report

**Rush Tower House
Rush Demesne
Kenure
County Dublin**

**Community Monuments Fund 2022
CMF22-1-DF003**

Archaeological licence ref.22E0494

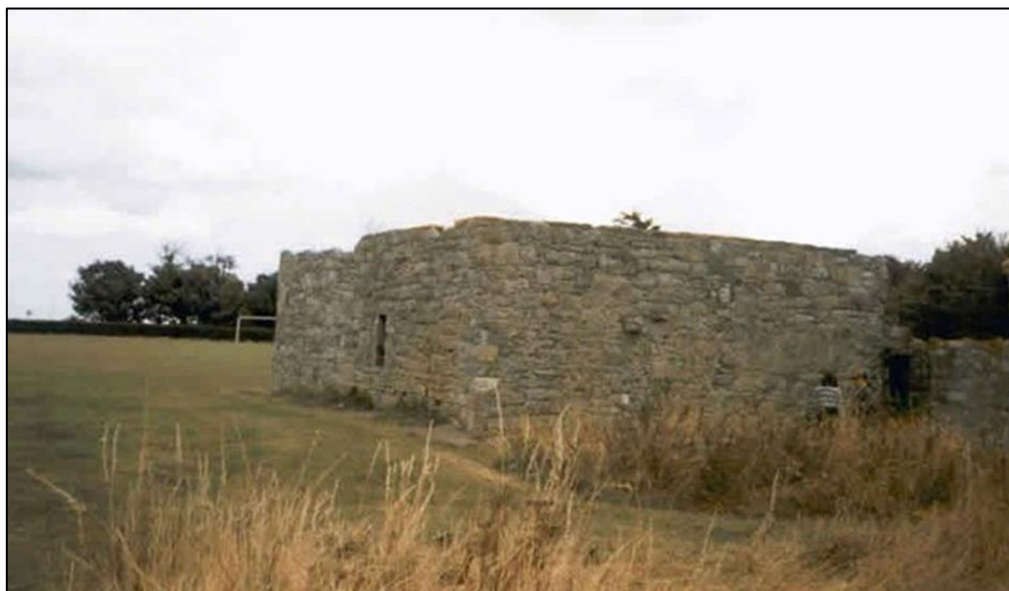
Plate 1 Rush Tower house, c.1990, facing southwest (Christine Baker)

In an overall sense the tower house would appear to be structurally sound, however the 1980's works carried out on the structure, the partial rebuild of southwestern corner tower & staircase (Plate 1) and resetting of access to the interior have not stood the test of time, casual but concentrated vandalism and the use of the monument as a focal point for several decades of antisocial behaviour have taken their toll, as evidenced by the removal of the gate at the foot of the staircase, which would have prevented access and the damage to the railings which were imposed on the staircase for safety.

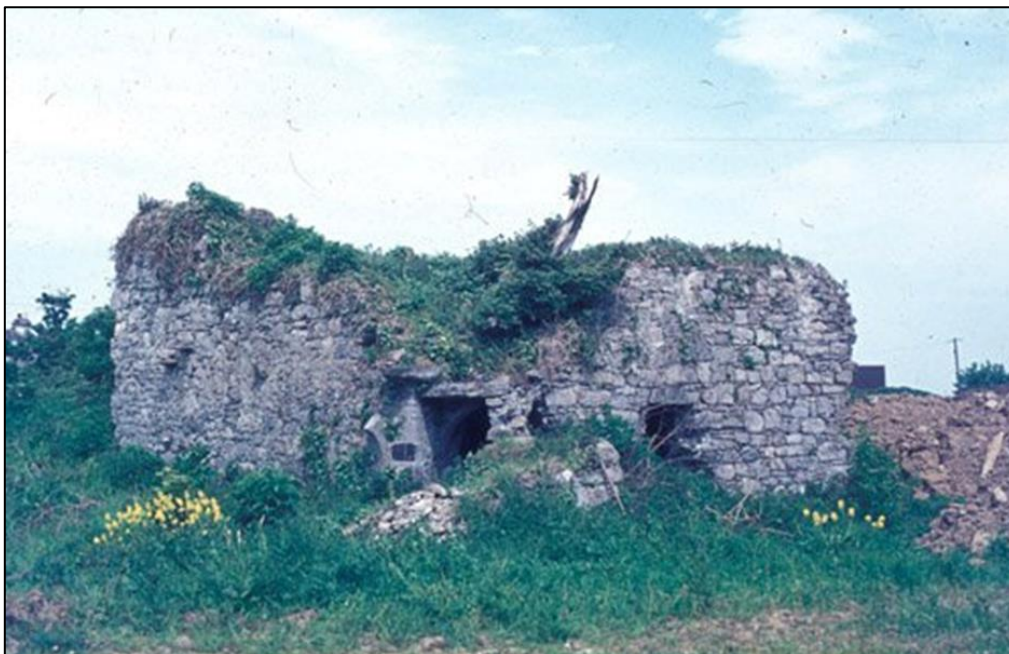
Plate 2 View of Rush tower house c.1970's, facing southeast (Christine Baker)

would appear to have been raised to some degree, judging by the dumped soil evident in the right-hand side of Plate 2 and the present ground level vs the window height at along the eastern elevation (Plate 5). Thus, any features associated with the tower house, such as a bawn wall, might be masked beneath this dumped material, at the original ground level. It is sadly not possible to suggest the original height of this monument, but it would have intentionally commanded extensive views of the coast road between Rush and Skerries in addition to the nearby stretch of the Irish Sea coastline, from Skerries south to Rogerstown, Portrane and Lambay.

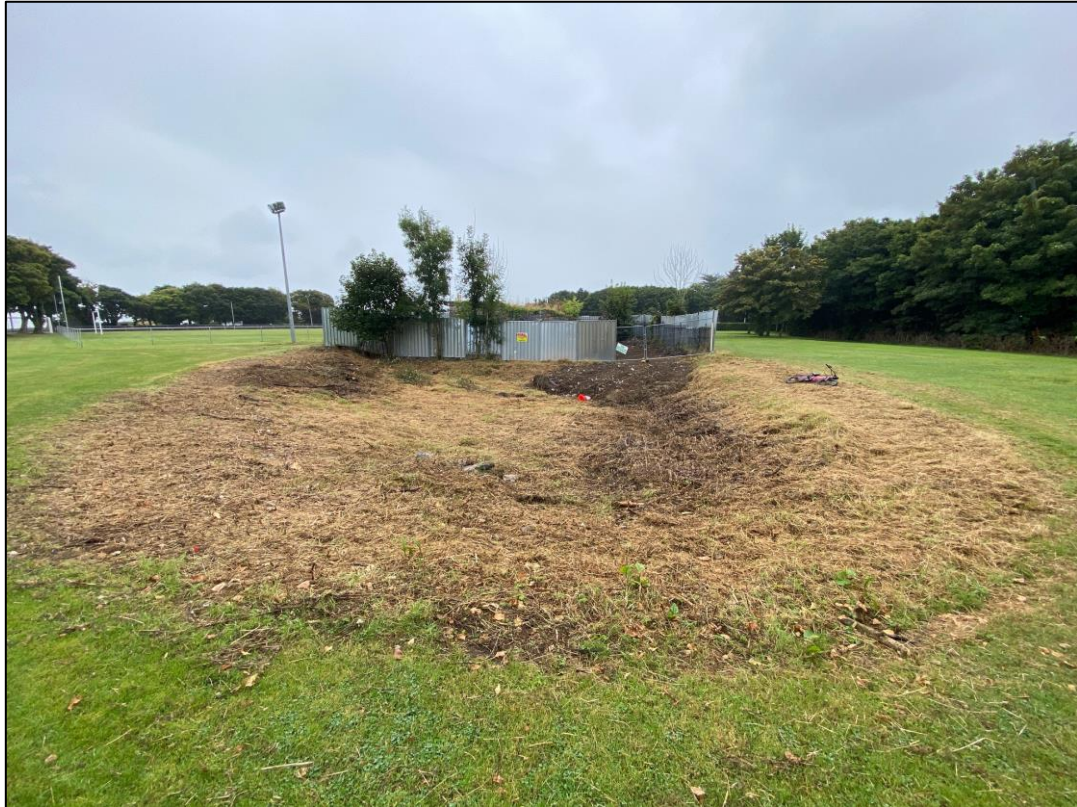
Plate 3 Hollow area to north of Tower House, post vegetation clearance

- 3.2 Work on site commenced 26th August 2022 and this initially focussed on the removal of the vegetation growth from around the structure, internal to the surrounding fence and the removal of the vegetation growth from the hollow area (Plate 3), exterior to the galvanised palisade fence, to the north of the Tower House and an additional, non-see-through metal security fence was installed around the perimeter, on a temporary basis, to protect the works from vandalism. During the course of those works a large number of stone fragments were uncovered which could originally have been part of the Tower House. These were carefully set to one side for examination by the author and their subsequent re-use in the conservation works (Plate 4). In the absence of the vegetation, a consideration of the eastern elevation of the Tower House, post ivy/vegetation removal and the relative level of the window opes therein (Plate 5) set against the present ground level would appear to again underline the extent of the 1970's building up of the surrounding ground level.

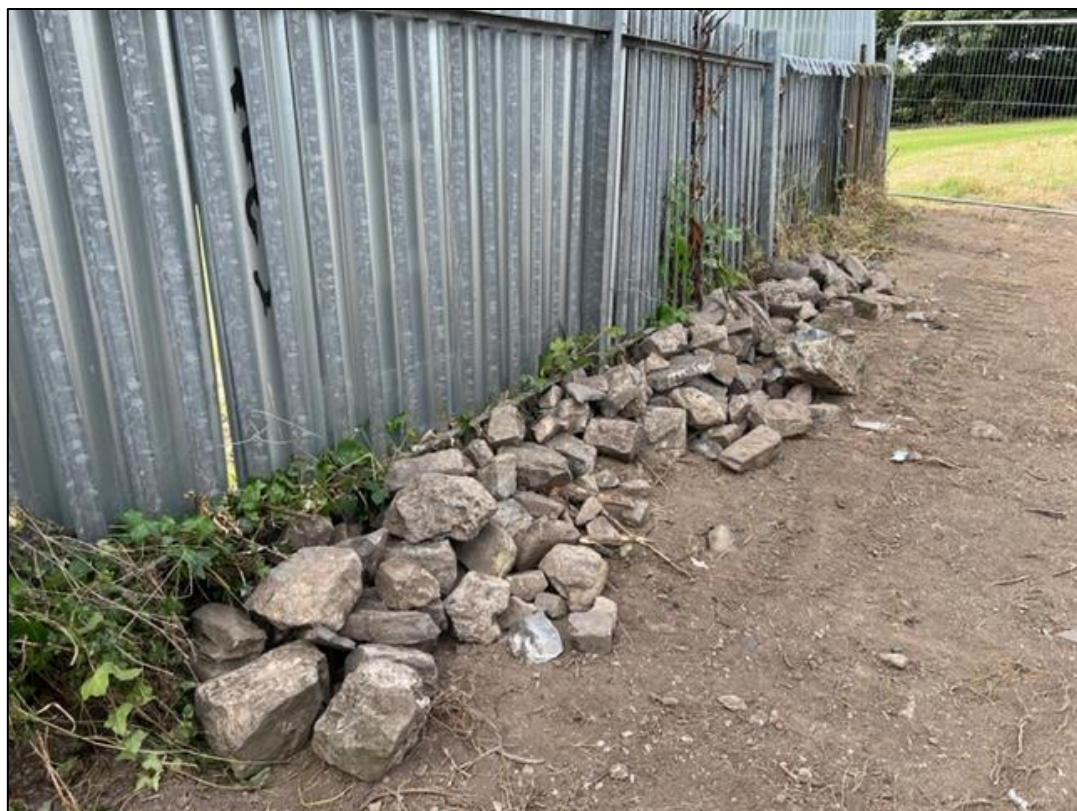
Plate 4 Structural stone uncovered during vegetation clearance

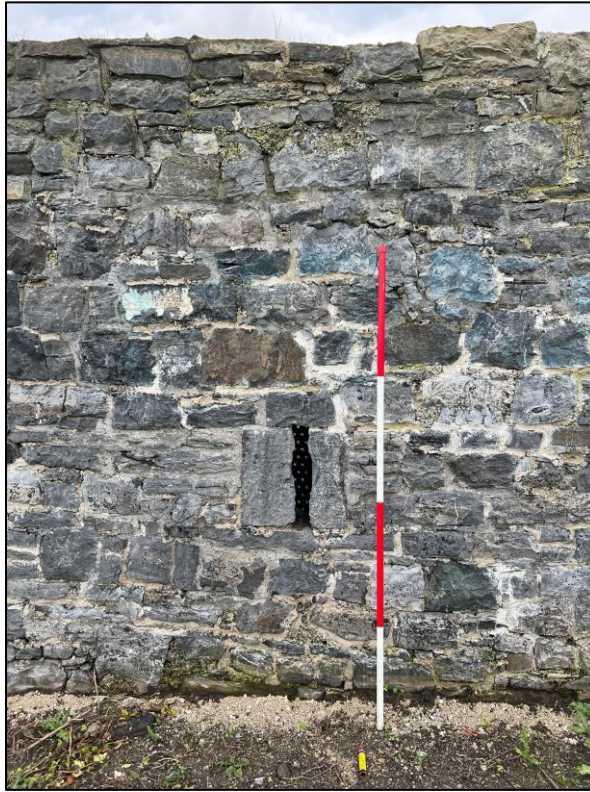
Plate 5 Eastern elevation showing height of window vs present ground level

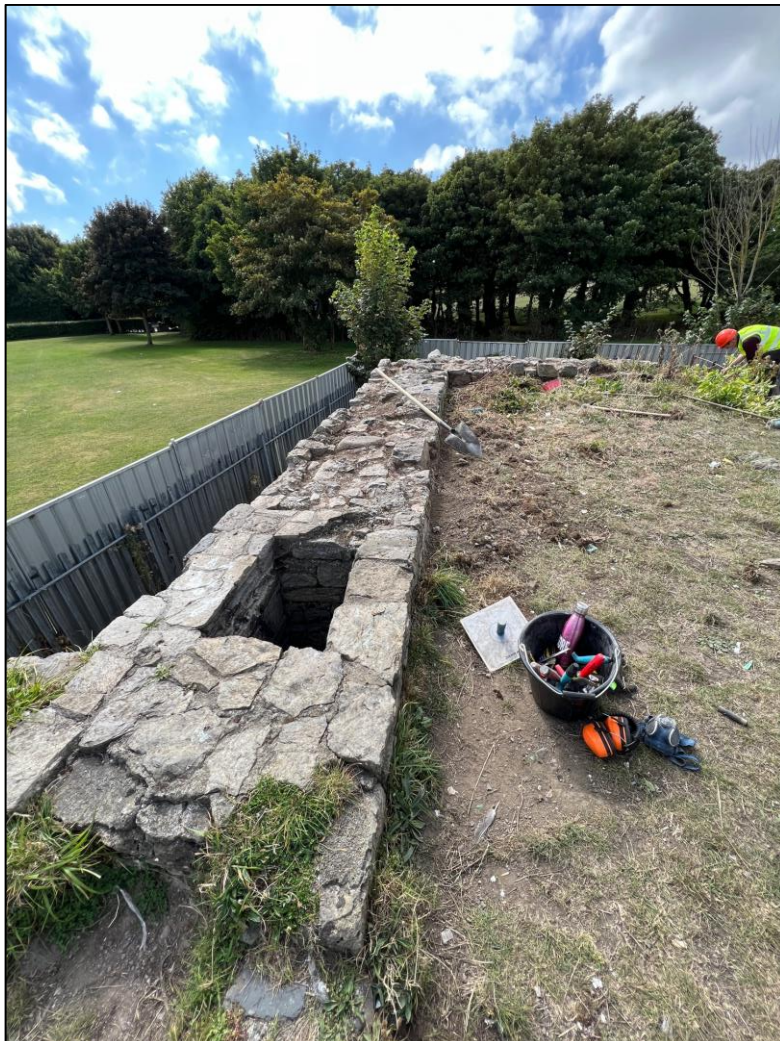
Plate 6 Vegetation removal from top of vault, facing west

The removal of the vegetation, which was on top of the barrel vault, at first floor level was undertaken (Plate 6) and following on from that the exposed surfaces of the walls at first floor level were flanchued to assist in water runoff and the damaged metal railings were removed to facilitate a partial rebuild of the existing corner tower to near first floor level (the height of the c.1980 repair) was undertaken (Plate 7). This made preferential use of any uncovered original dimension stone and architectural fragments, such as the dressed quoin stone (Plate 8), with its mason's mark (possibly an inverted capital G -Plate 9). Following the completion of those tasks a sealing puddle clay layer was applied to the external first-floor level, atop the barrel vault and a soft capping of grass turves was installed to protect the masonry of the structure and to prevent water ingress (Plate 10).

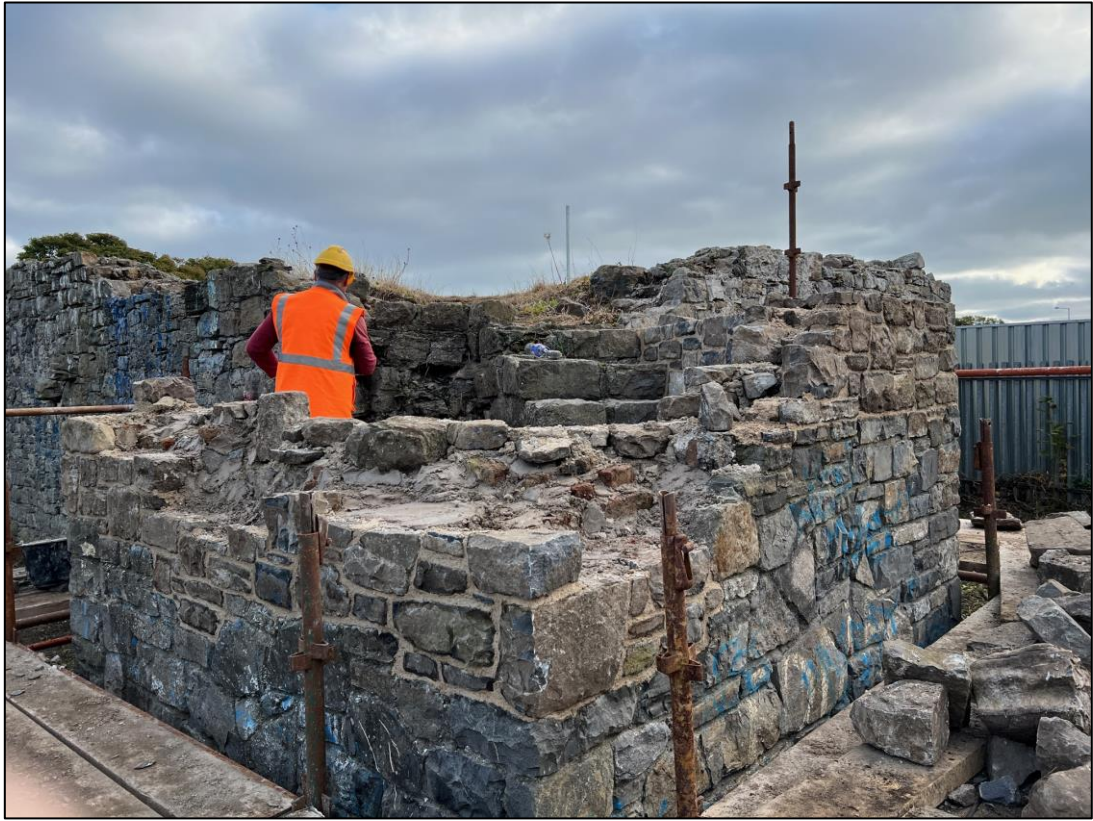
Plate 7 Rebuilding of corner tower, facing southeast

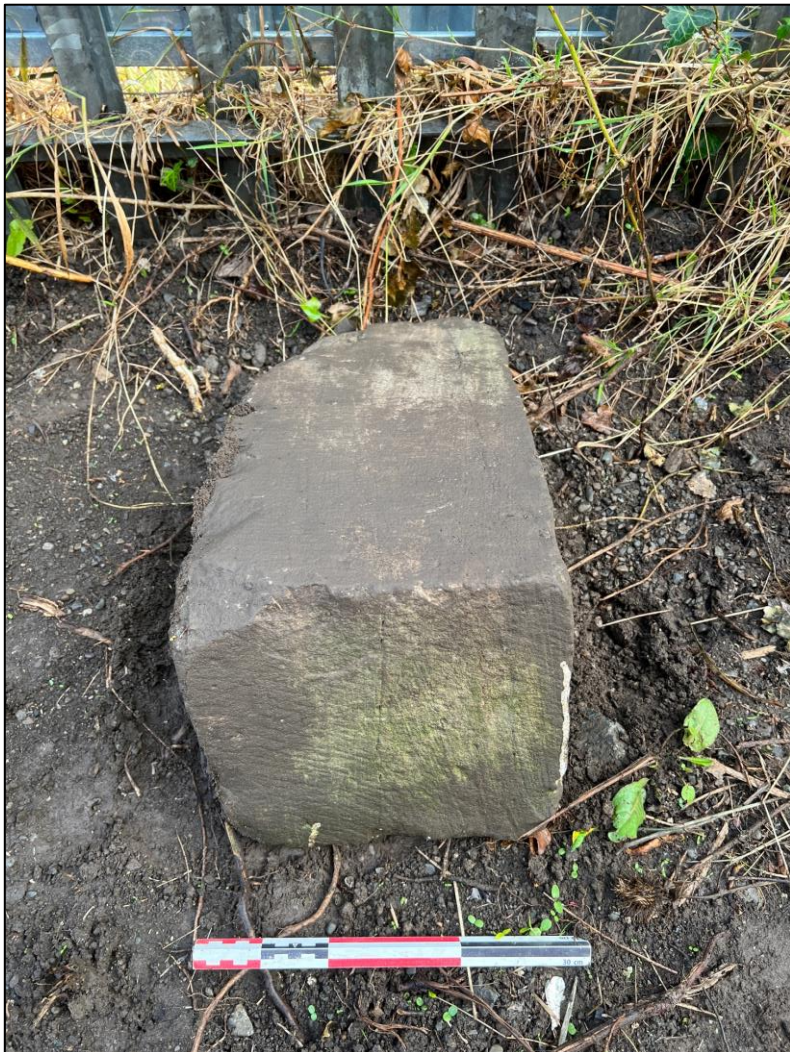
Plate 8 Dressed quoin stone

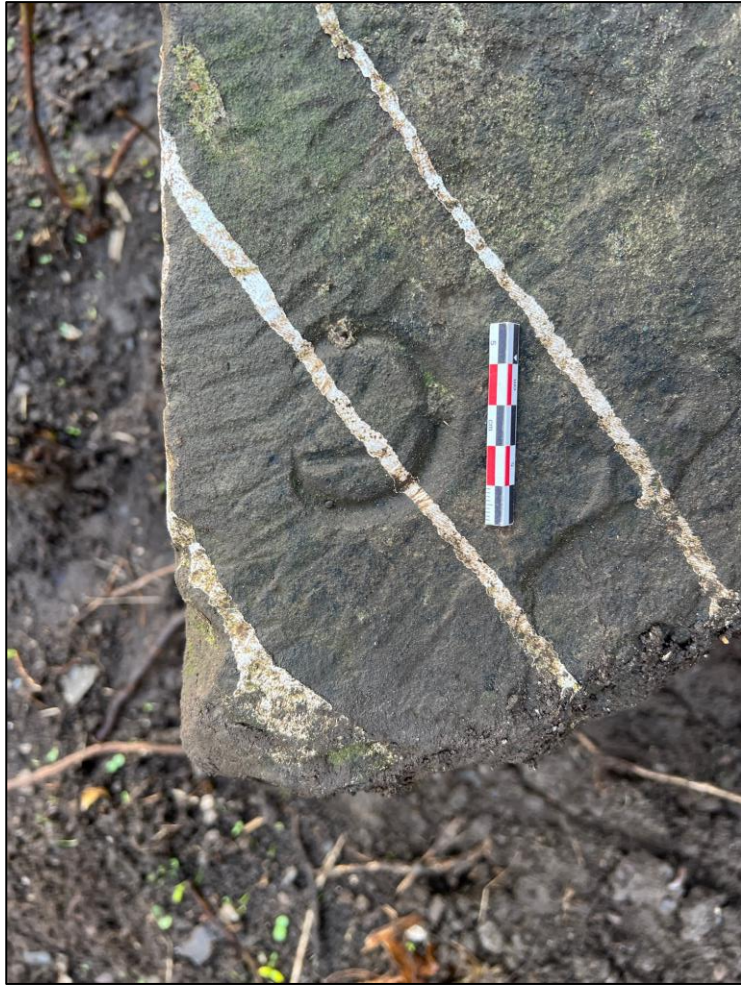
Plate 9

Mason's mark on quoin stone

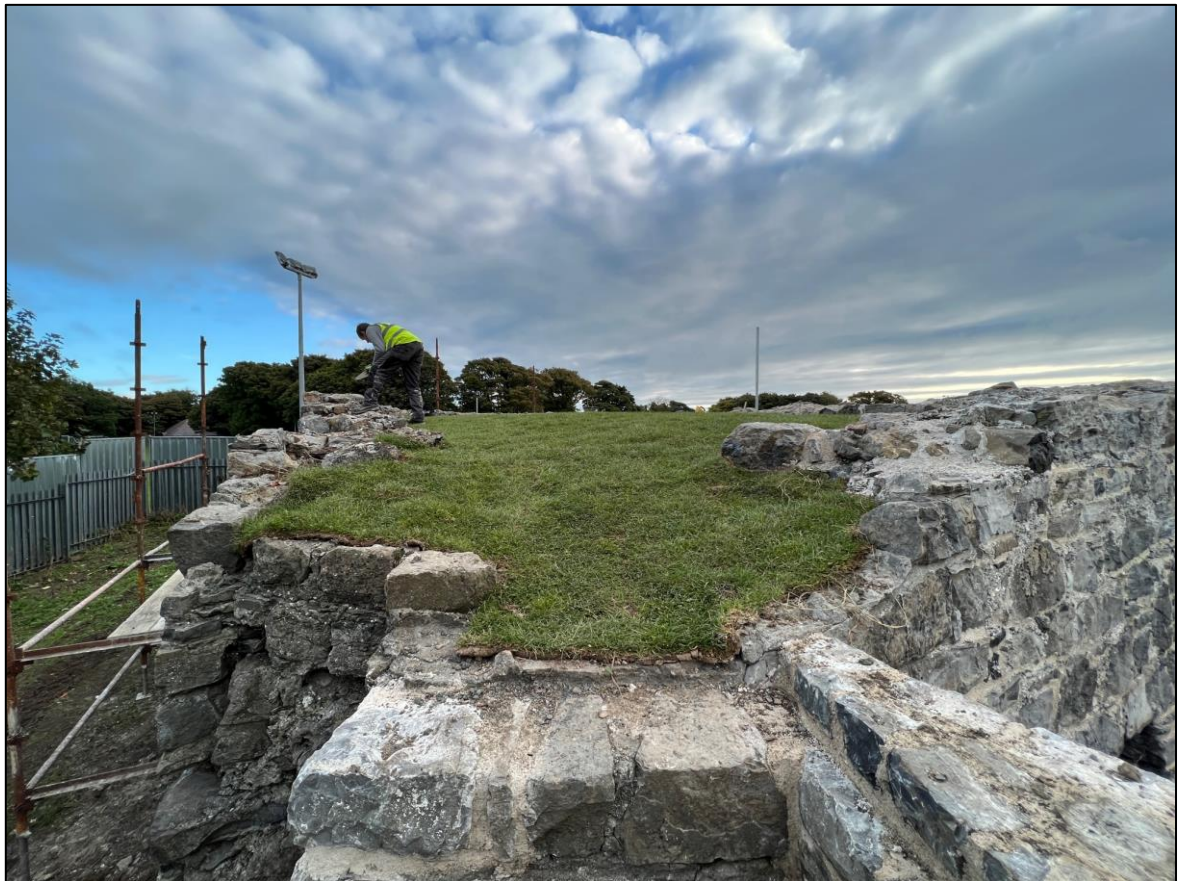
Plate 10

Soft capping on top of vault, at first floor level, facing east

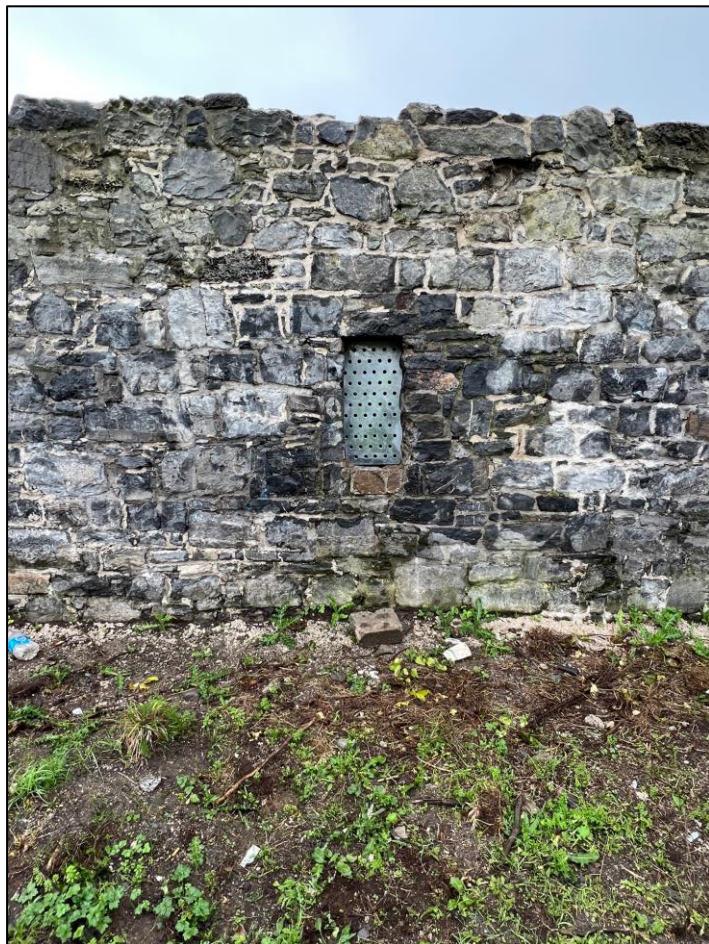
Plate 11 Eastern elevation post graffiti removal, with secured ope, facing west

At that point all of the opes (Plate 11) and the access via the reconstructed entrance (Plate 12) was sealed with galvanised metal security panels and any unused architectural and dimension

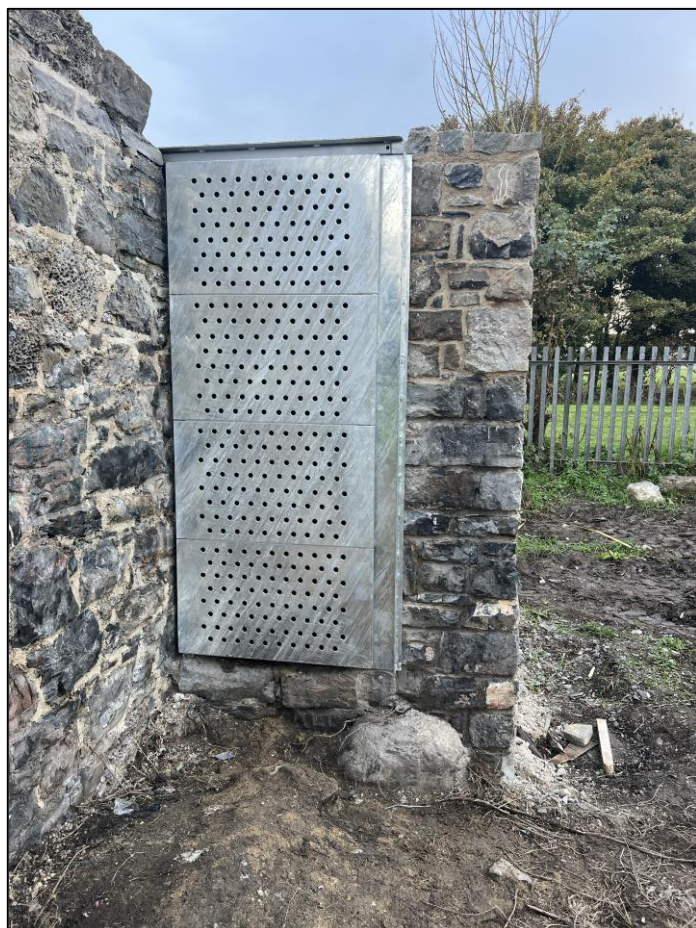
Plate 12 New steel security door on staircase/tower entrance

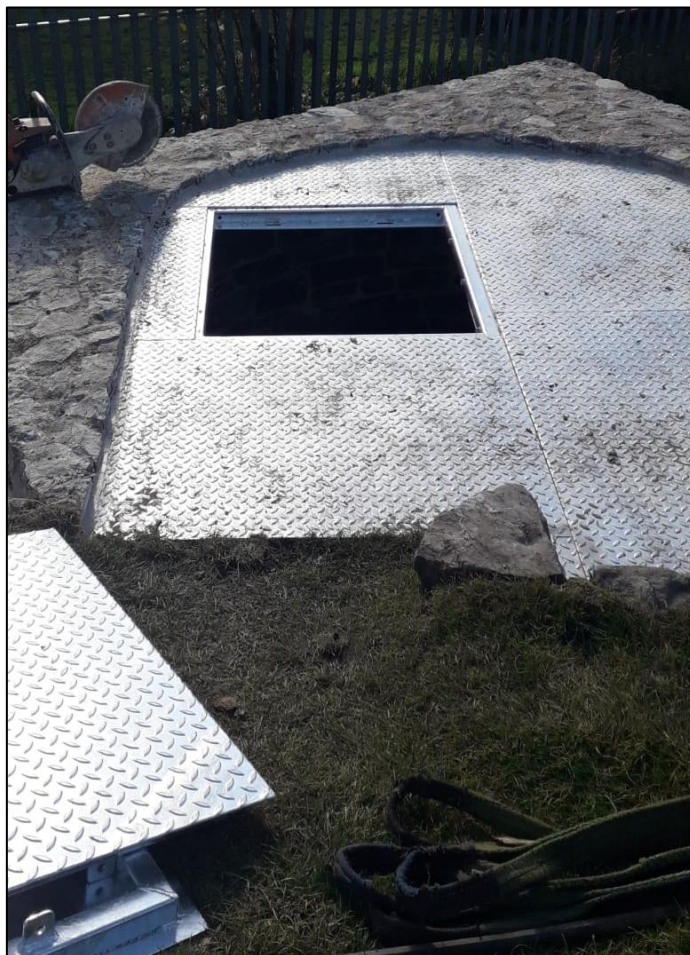
Plate 13 Roof access metal plate and trap door hatch, facing northwest

stone fragments were placed on the newly secured interior of the structure. Access to the 1st floor has been secured and preserved by a metal trap door and plate arrangement (Plate 13).

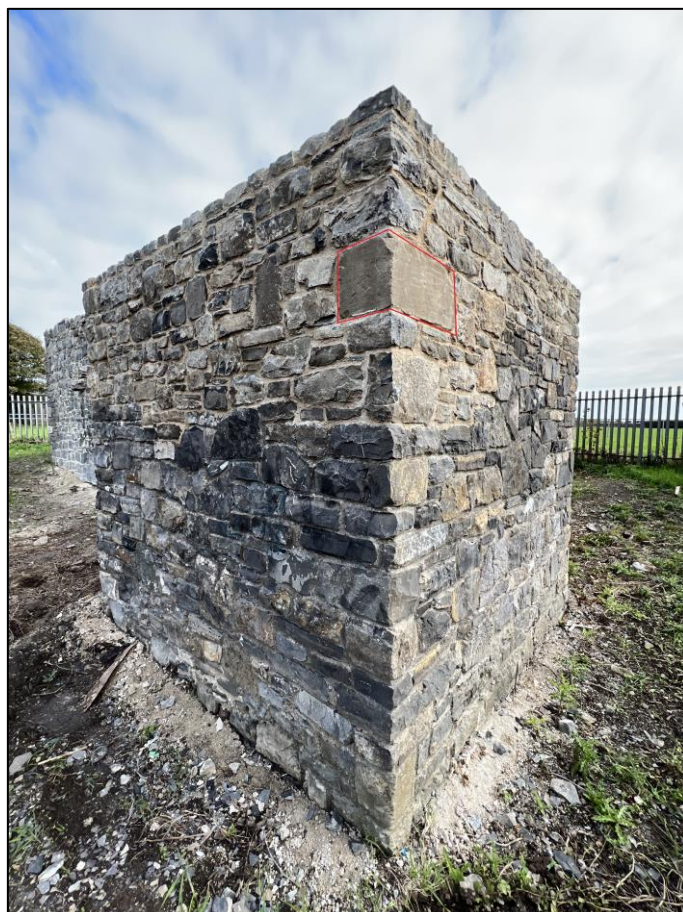
The solitary dressed quoin stone (Plate 14), in addition to some of the other architectural stone fragments, offer a tantalising glimpse of the upper floor(s) of the structure, which we can now suggest were somewhat ornate, with square quoins from first floor level and window opes which possessed glazing bar holes. As a result, the following actions are suggested in order to further investigate this enigma of a monument and to add to the overall appreciation of its heritage and significance:

Plate 14 Partially rebuilt corner tower, with re-used quoin stone highlighted in red, facing southeast
